Analysis of Shielding Effectiveness at ...

Executive Summary –

A General Electric MRI Test Room initially measured -55 dB isolation. Although damage was found to the door frame and RF fingerstock around the door, it was also found that the main RF leakage at 100.5 MHz was occurring due to improperly secured shield panels and hardware for cable pass-through between the MRI test room and the MRI equipment room. After replacing damaged finger stock around the door and shimming where the door frame had been damaged, re-installing cable pass-through shield panels properly, and replacing missing hardware on the shield panels, the leakage was reduced to a worst case of -101.1 dB, meeting the MRI Test Room's required leakage specification of greater than -100 dB.

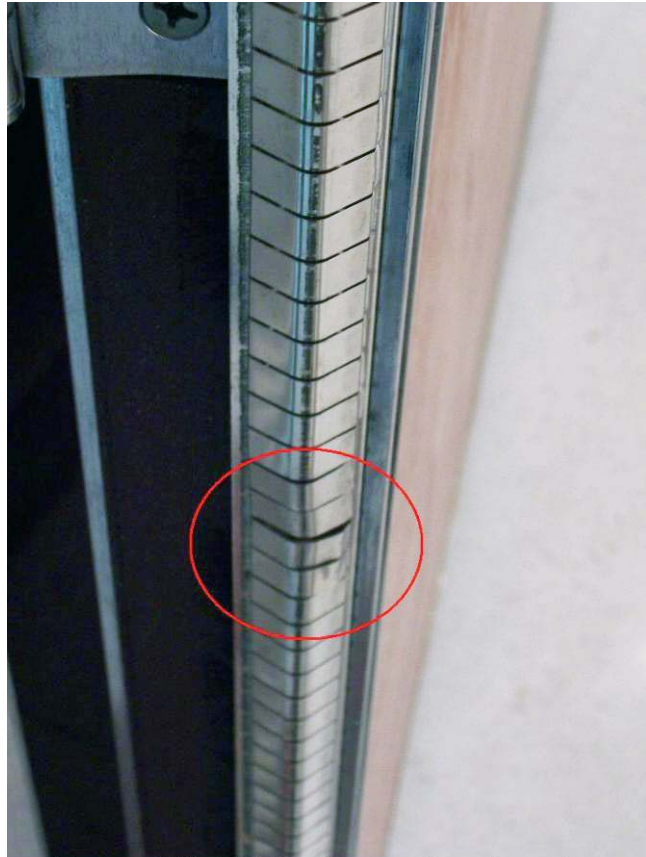
Initial inspection of the room found that fingerstock on the RF-tight door had been damaged in three places.

The photo to the right shows damaged fingerstock, apparently caused by a patient gurney striking the door. Although not shown in the photo, the door frame itself was also found to be dented, most likely from being struck by another patient gurney, resulting in a visible gap between the door frame and the fingerstock.

Damaged RF-shielding fingerstock on door edge.

Cleaning the door frame and fingerstock (see the photo below), replacing the finger stock in several areas, and shimming the finger stock where the door frame had been bent, helped; but it was found that the door, itself, was not the main leakage source.

We found that the fingerstock on the edges of the door was damaged in three locations, as well as being dirty, preventing a good, low-resistance contact with the metal doorframe. The doorframe itself was also found dented, apparently as a result of being hit by a patient's gurney (at least one of the fingerstock damage is also suspected to be resulted from contact with a gurney). Thus, 360°RF recommends that greater care be taken when moving a gurney or other object through the doorway to prevent damage.

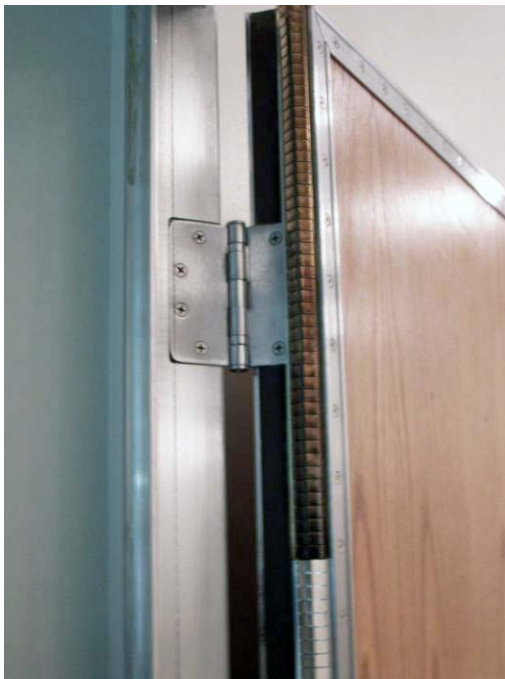
Dirty fingerstock on inside of door

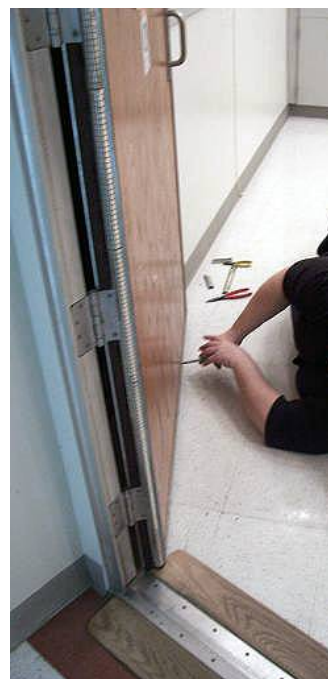
Engineer replacing damaged fingerstock

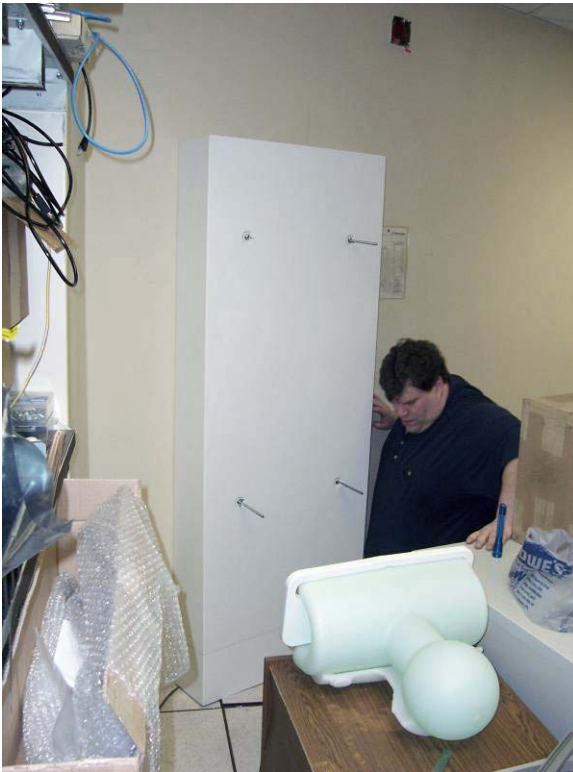
The main source of RF leakage, measured at 100.5 MHz, was found to be around the cable feed-through panel in the equipment room. The inner shield in the MRI room was missing two of four grounding fasteners, and the bottom shield was loose. The top and bottom shields in the equipment room had been completely removed and many of the securing bolts were found to be loose; see the photos on the following page.

Engineer examining removed shield panel in equipment room

The cable pass-through and shield panels were reinstalled, missing hardware was purchased and installed, and loose hardware was properly tightened. Further measurements now found the shielding had improved to better than -100 dB.

The attending RF engineer also found shield panels both missing as well as improperly reinstalled, perhaps while work was performed on cables. These shield panels are essential to obtaining high RF isolation of the MRI Test Room and should always be reinstalled properly, with all fasteners properly secured and tightened.

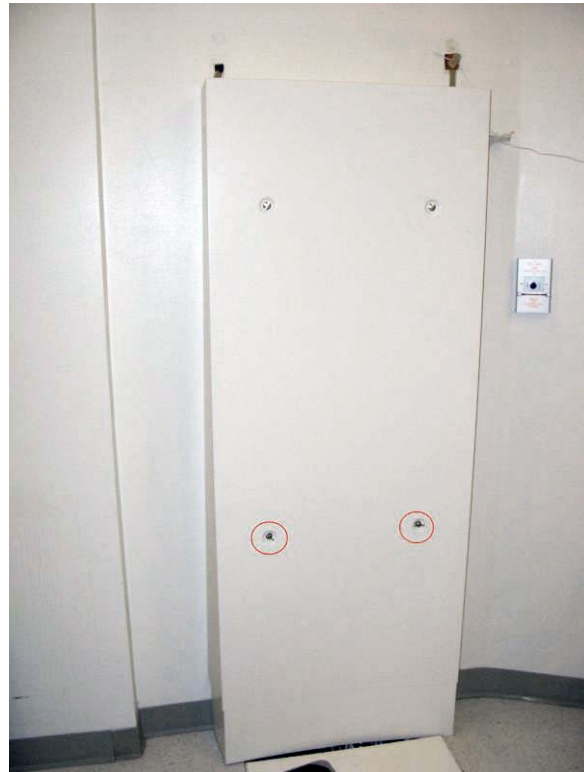
Two of four shield panel fasteners were found missing in the MRI room (red circles).

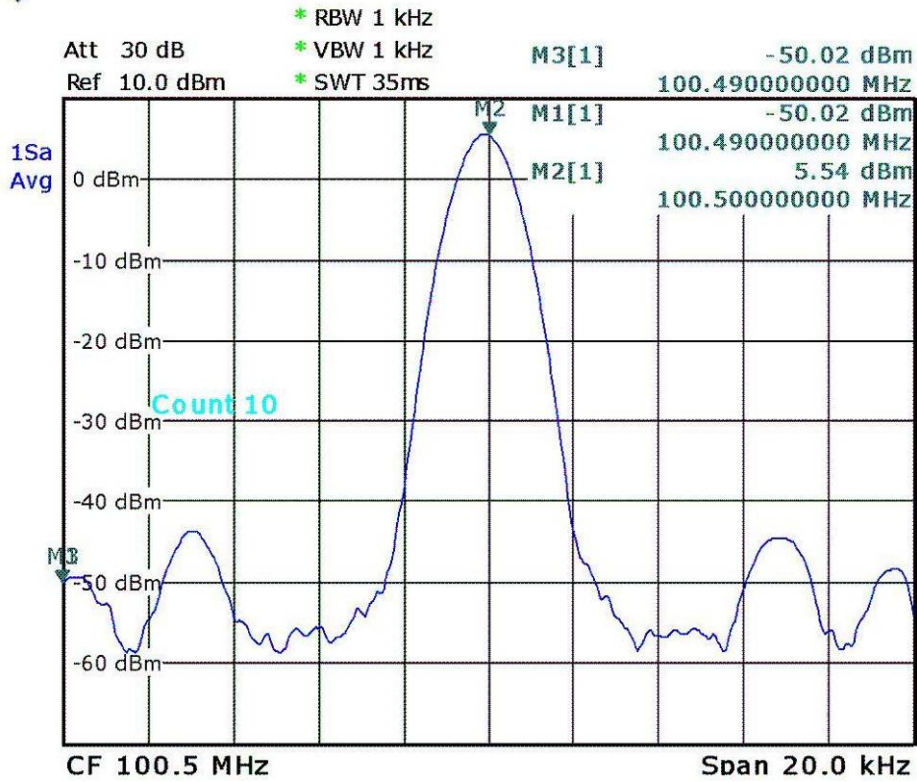
Plot showing measured signal level with MRI room door open

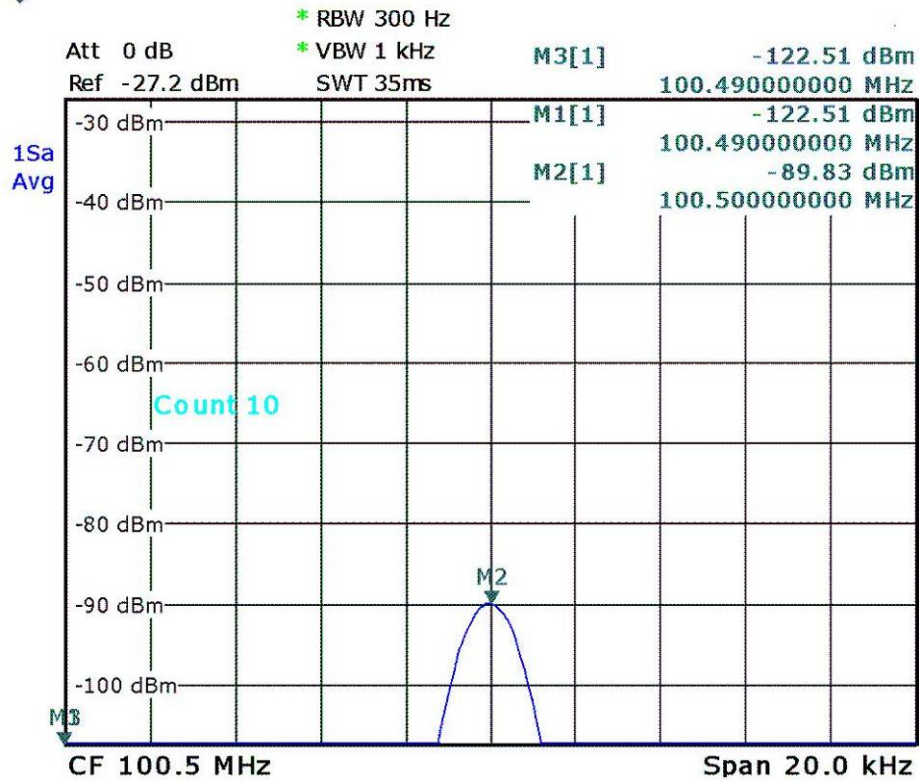
Plot showing measured signal level with MRI room door closed

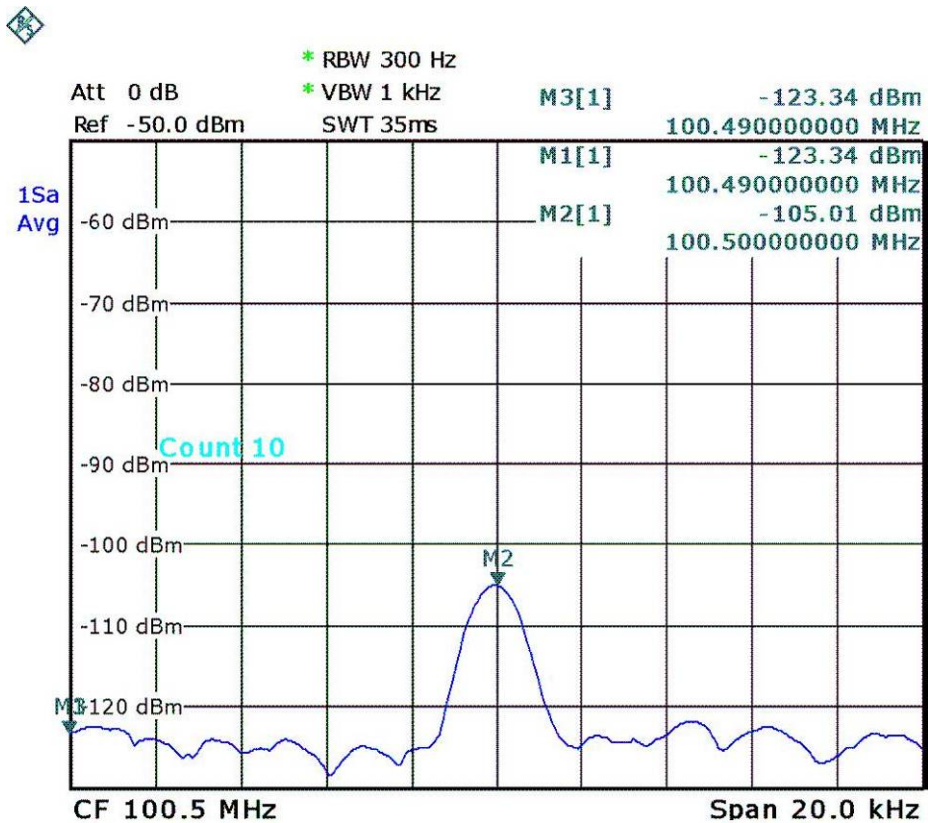
Plot showing measured signal level outside building along North wall (see photo below)

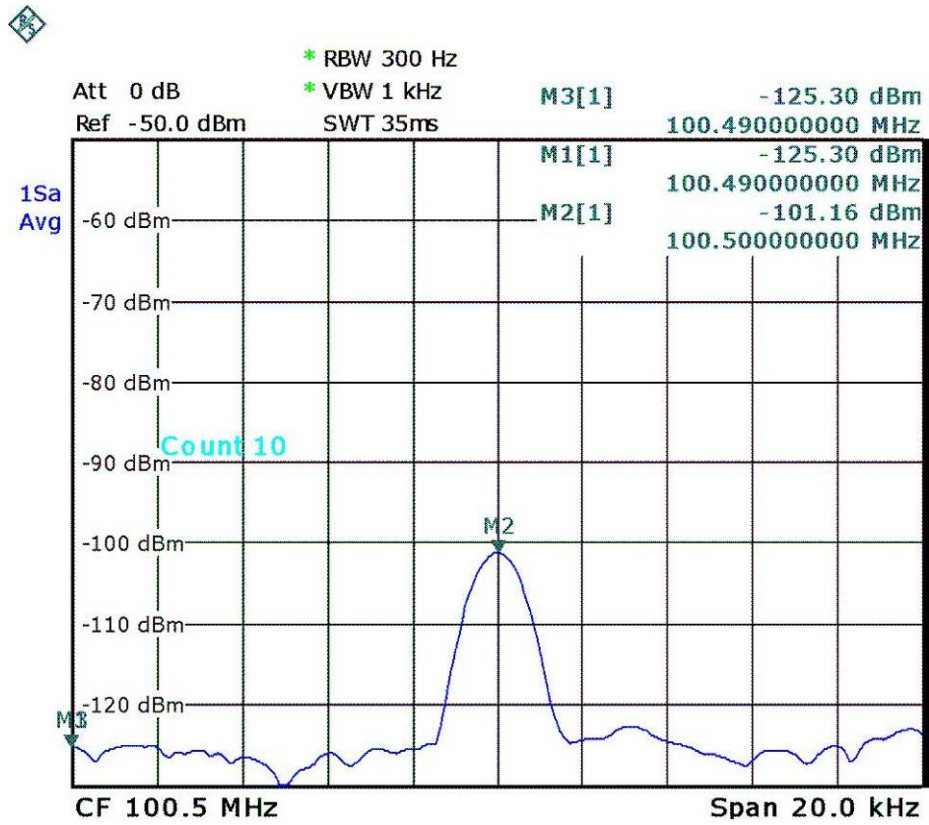
Plot showing measured signal level inside the equipment room at the observation window
