Introduction:

360°RF was retained to independently test four point-to-point 4.9 GHz public safety radio systems manufactured by a leading brand for performance versus published specifications. Further, 360°RF analyzed and/ or tested these devices' construction, circuitry, harmonics and microphonics, leads, materials, and solder joints.

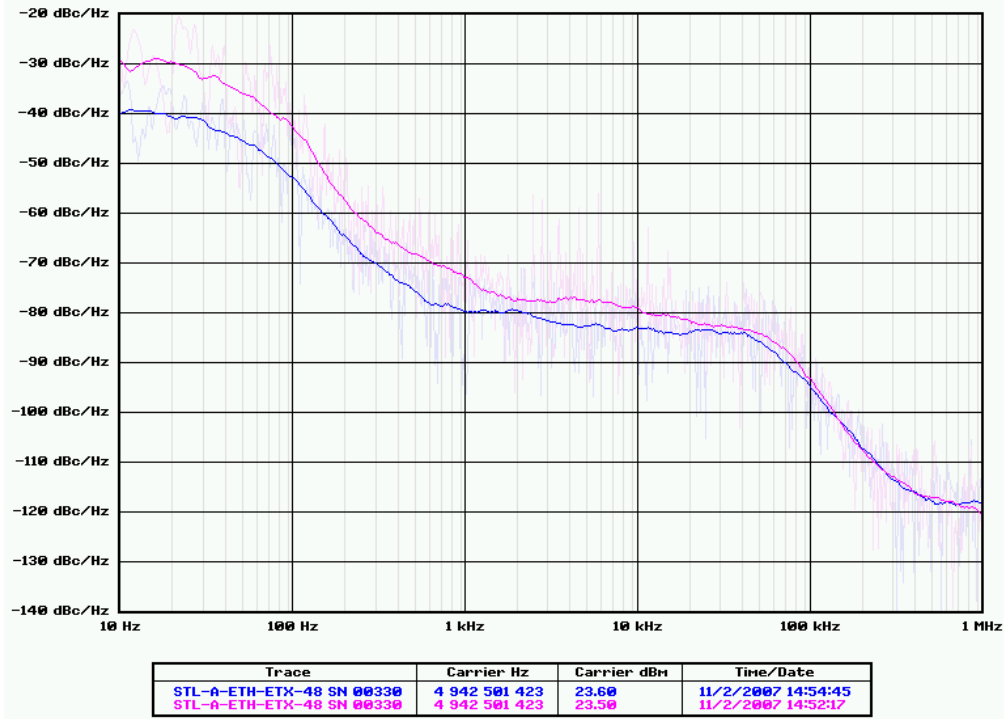
Next, we looked at the phase noise performance of the CW tone produced by the ODU. In the plot shown below, the top line (purple) was taken while the case was subjected to repeated vibration on the exterior of the radio's case (metal tools drug along the heatsink ribbing). The lower line (blue) shows the phase noise when no external vibration was added. There is roughly a 10 dB difference in phase noise from 10 Hz to 1 kHz when external case vibrations are present. This test was repeated three times on the ODU-4 serial number unit with similar results each test, indicating the presence of microphonic coupling.

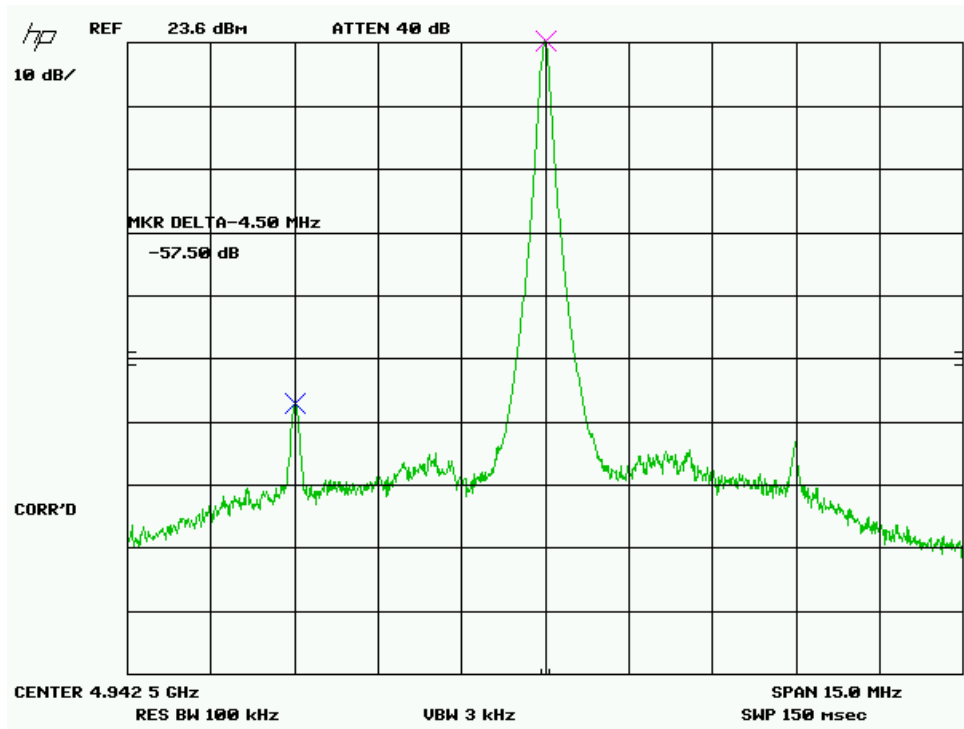
The plot below is of the ODU-4 unit with CW tone on and maximum power output selected. With the radio on channel 3 (4.9425 GHz), we checked for harmonic energy at 9.885 GHz and 14.8275 GHz. No harmonics were detectable down to the noise floor of our analyzer. Two sideband signals were present in the CW analysis at +/- 4.5 MHz with the lower sideband being the strongest at -57.5 dBc (see secondary marker in CW plot).

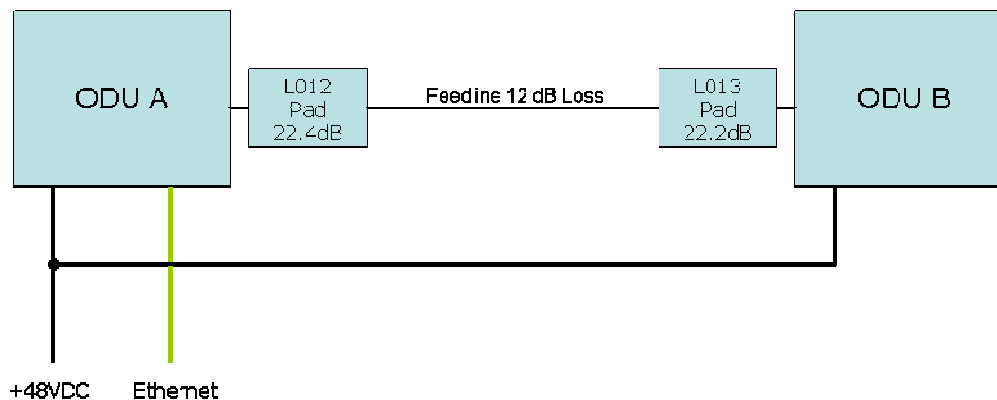
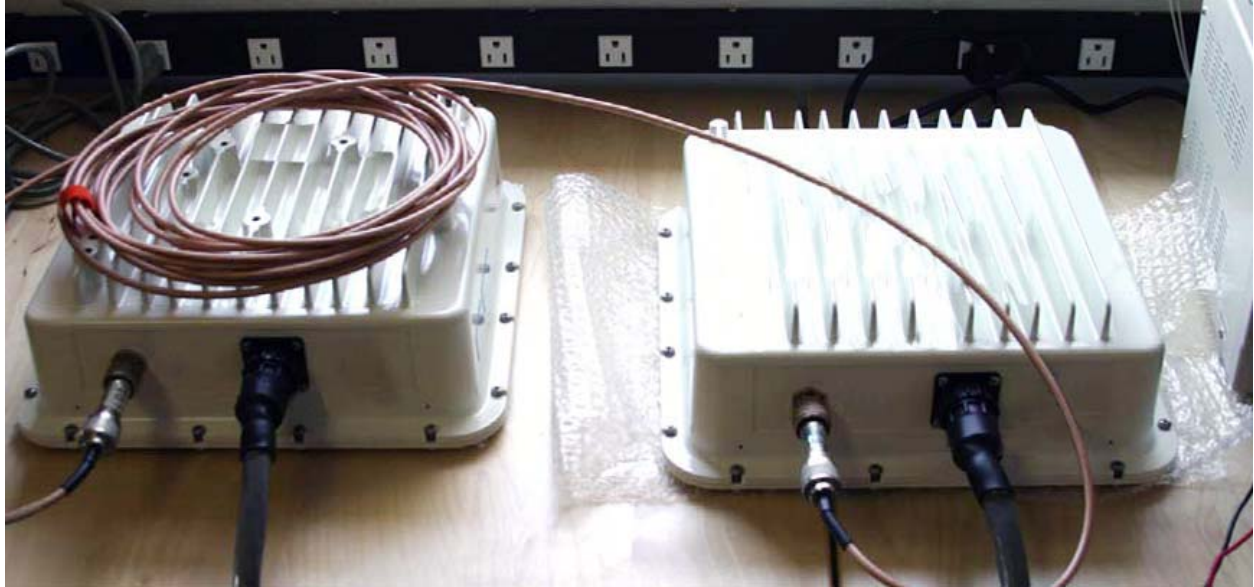
Next, two units were connected together with 56.6 dB loss between the two units to determine if any microphonic effects were present (see diagram and photo below). 56.6 dB insertion loss guarantees a strong signal so that any errors introduced would not be path-related. Both units were placed on the same table and powered from the same power supply at 48 VDC. After two units were connected, power was applied, and five minutes of settling time was allowed, all BER counters were reset, and the modems were watched for an additional five minutes. In all cases, no errors were observed. Both units were set to the 1 MHz bandwidth setting and automatic power adjustment. The units were placed on two layers of small bubble wrap to insulate them, physically, from each other and the work surface. When gently tapping on the work surface, no correctable or uncorrectable errors were reported by the ODU software.

When the tapping was moved to the outside of the case itself, however, errors were reported with each tap of the case. Sometimes the errors were corrected in software by the forward error correction, but often they were not correctable error bursts.

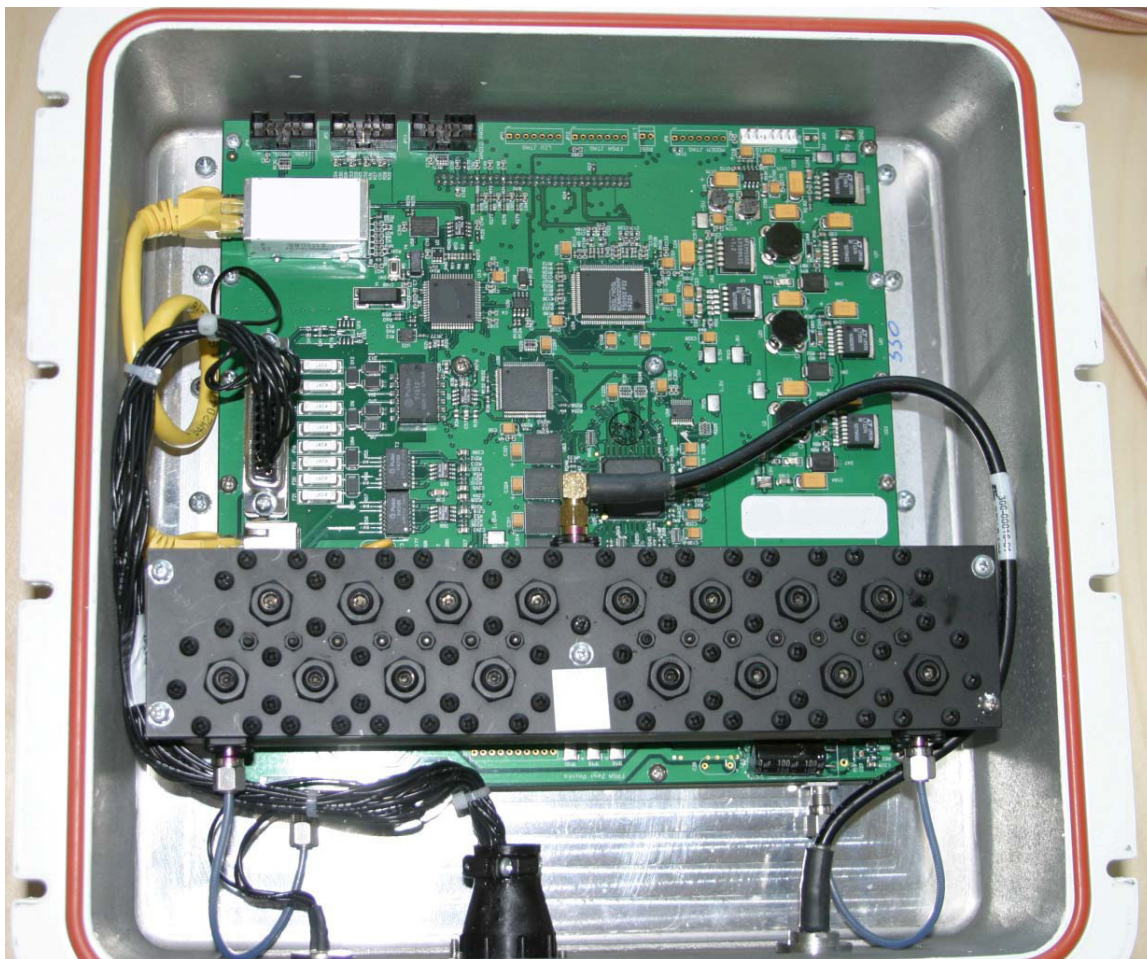
Next, the case was removed from both the ODU-3 and ODU-4 units for internal examination and to run further tests. The radios appeared to be well constructed both mechanically and electrically. Internal grounding was achieved through direct contact of the PCB with metal surfaces where solder mask was not present as well as through a ground lug to the exterior case. The unit is divided into two main printed circuit boards: one for control, logic and data, and the other for RF. The control board faces up in the case and an IDC connector on the rear of this board connects with a mating IDC connector on the rear of the RF board, which is mounted face-down in a machined aluminum block with individual cavities for RF sections. The RF board is secured to the milled aluminum enclosure with 55 screws, but no additional RF shielding is provided. Both the control and RF boards appear to be multilayer FR4. All solder joints appeared to be well formed. The entire assembly of two PCB's, diplexer and aluminum substrate is directly mounted to the external case without any cushioning.

Two small bursts of errors were taken when the case lid was removed and the unit was turned over, open. The ODU did not register any additional errors while it was sitting idle, open. A photo of the interior of the unit is shown below.

Again, a similar test of tapping a screwdriver on the outside of the case was performed and in each case, errors were registered. The error size was roughly equivalent to the errors taken in the “tap test” above, indicating that the microphonics observed do not appear to be affected by the position of the case lid.

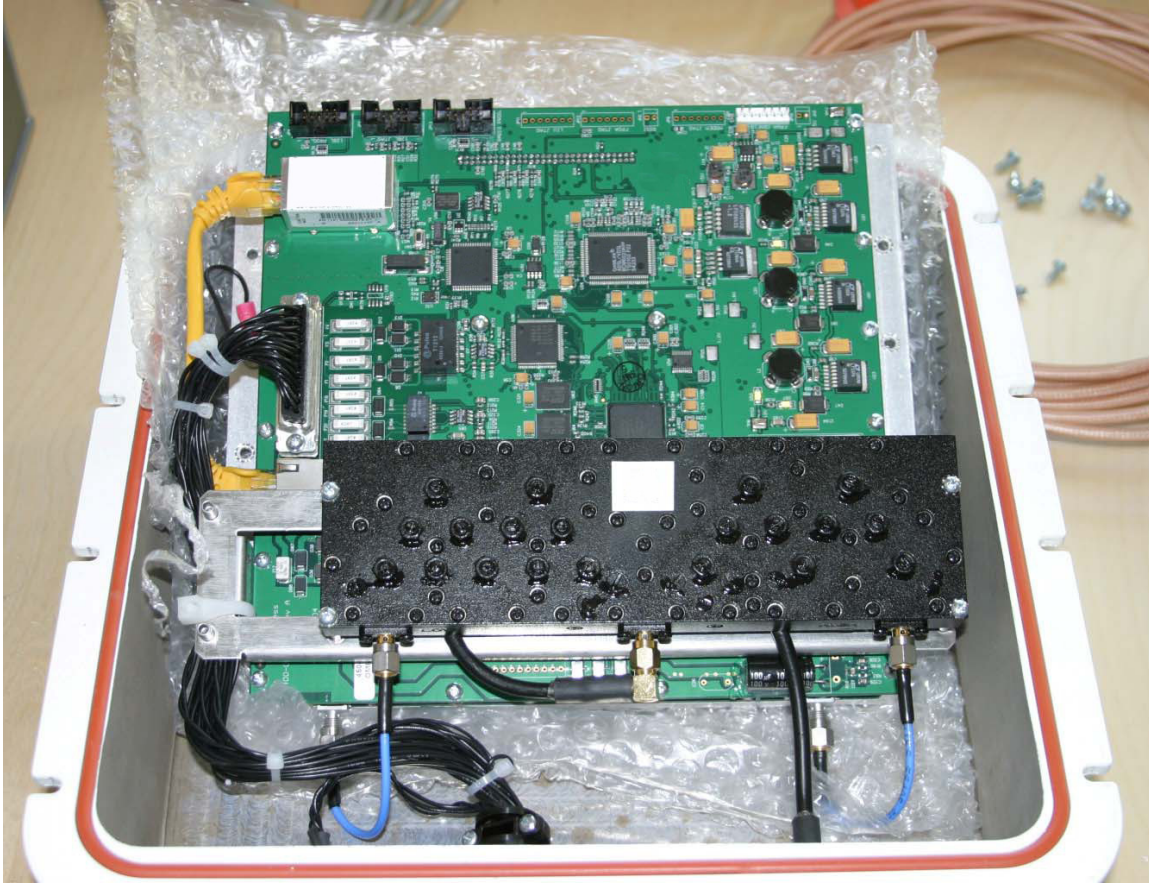
The “tap test” was run again with similar results as before. Next, the unit was pulled slightly from the enclosure and rested on the edge of the enclosure with bubble wrap mechanically isolating the assembly from the enclosure (see photo below).

The “tap test” was again repeated, but this time *errors were not registered unless the tap intensity was significantly increased*. This result indicates that some mechanical isolation between the assembly and the case would reduce the effects of the microphonics.
