Introduction:

Reported Condition: Poor 2.4 GHz ISM connectivity in store corner, etc. Store served by 5 dispersed Cisco APs.

Site Survey: Storewide WiFi RF Environment

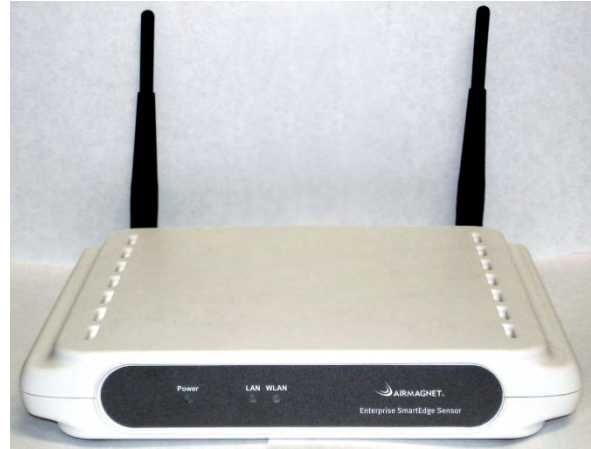
In the process of initial survey of the store, an “AirMagnet” unit was discovered in the center of the store near AP1. This unit is intended to help identify and manage wireless LAN threats. In addition to monitoring for ‘rogue’ (unauthorized by user) access points, the manufacturer claims to support “true spectrum analysis.” If the manufacturer’s claims are accurate, most of the functions performed by 360°RF could be accomplished remotely. The one exception to this is the ability to move about the store.

Figure 1 AirMagnet 5020 Sensor

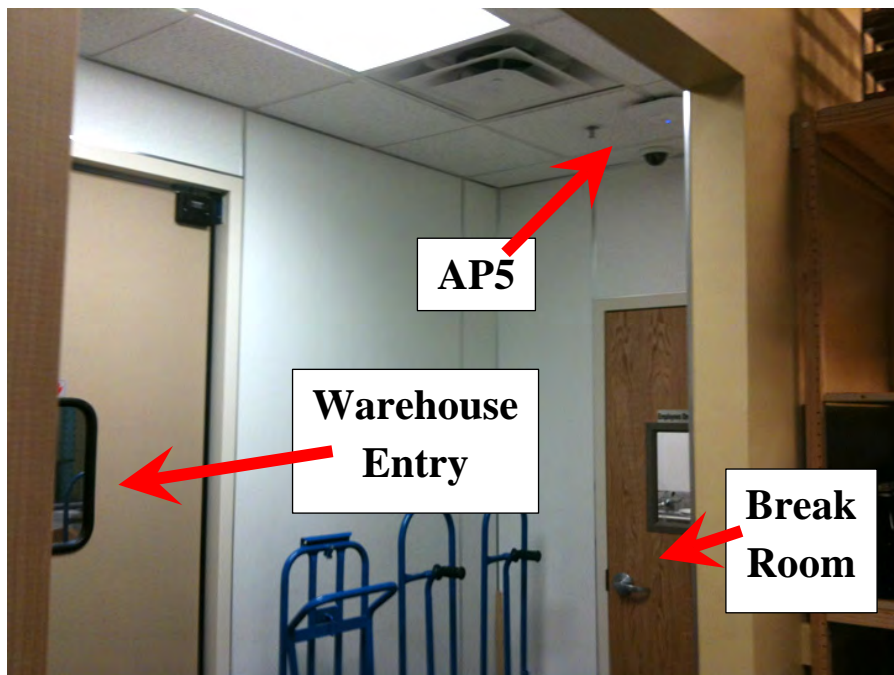
AP5 should have been located in the warehouse according to Figure 3 shown on page 4. The actual location of the AP is above the entry to the break room. See Figure 2, below. This may have been caused by the fact that the warehouse entry doors are not located as shown on the drawing in Figure 3, and instead are set back from the location shown in the drawing. Ideally this AP should be located in the center of the warehouse or slightly toward the front of the store.

Figure 2 AP5 Location

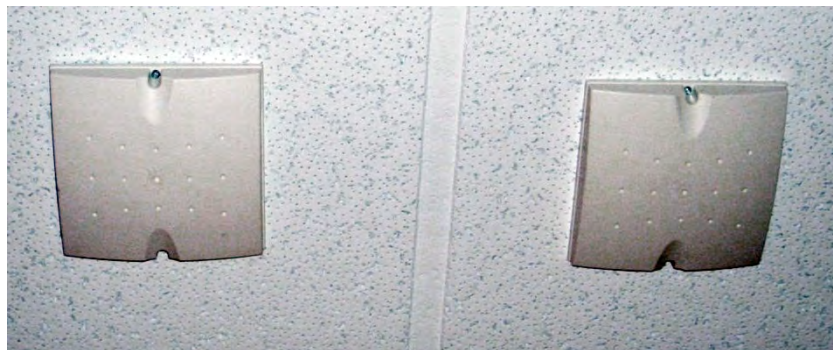
Two apparent antennas were located roughly midway between the location AP2 and AP6. 360 could detect no energy from these in the 2.4 or 5 GHz bands. Their purpose is unclear.

Figure 3 Unknown Antennas

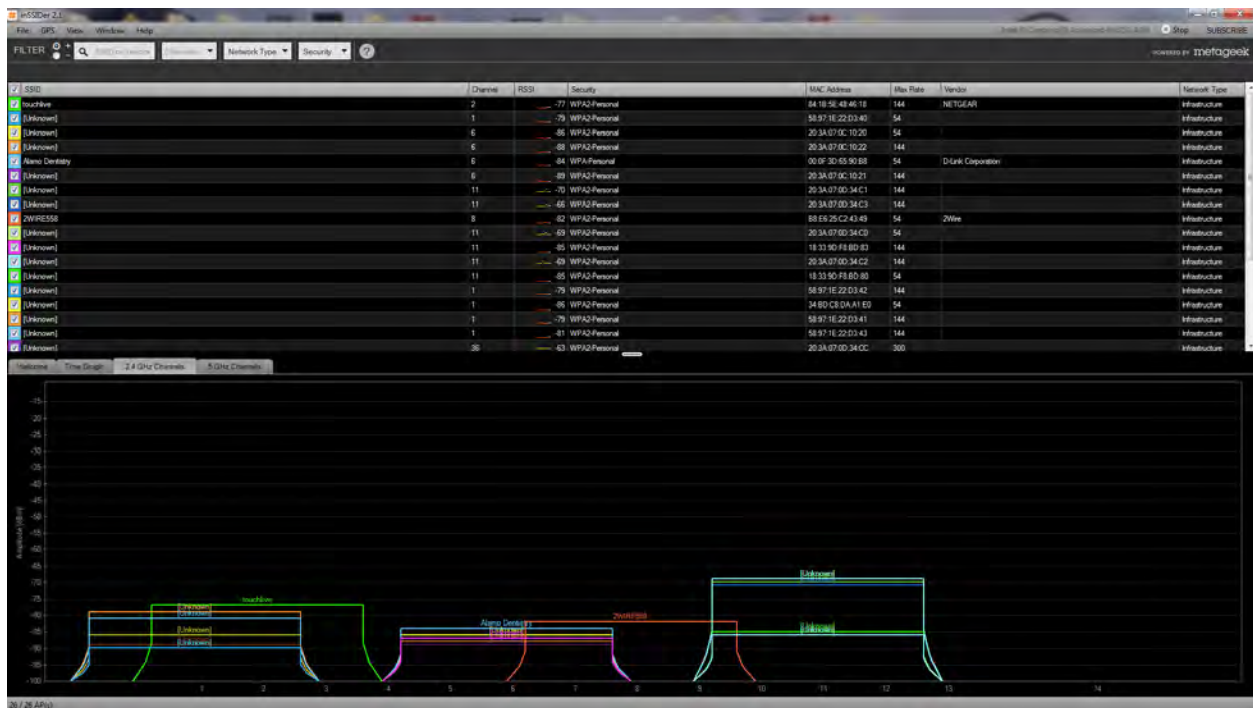
Figure 5 WLAN view at 0630 on 10 NOV 20xx from Office

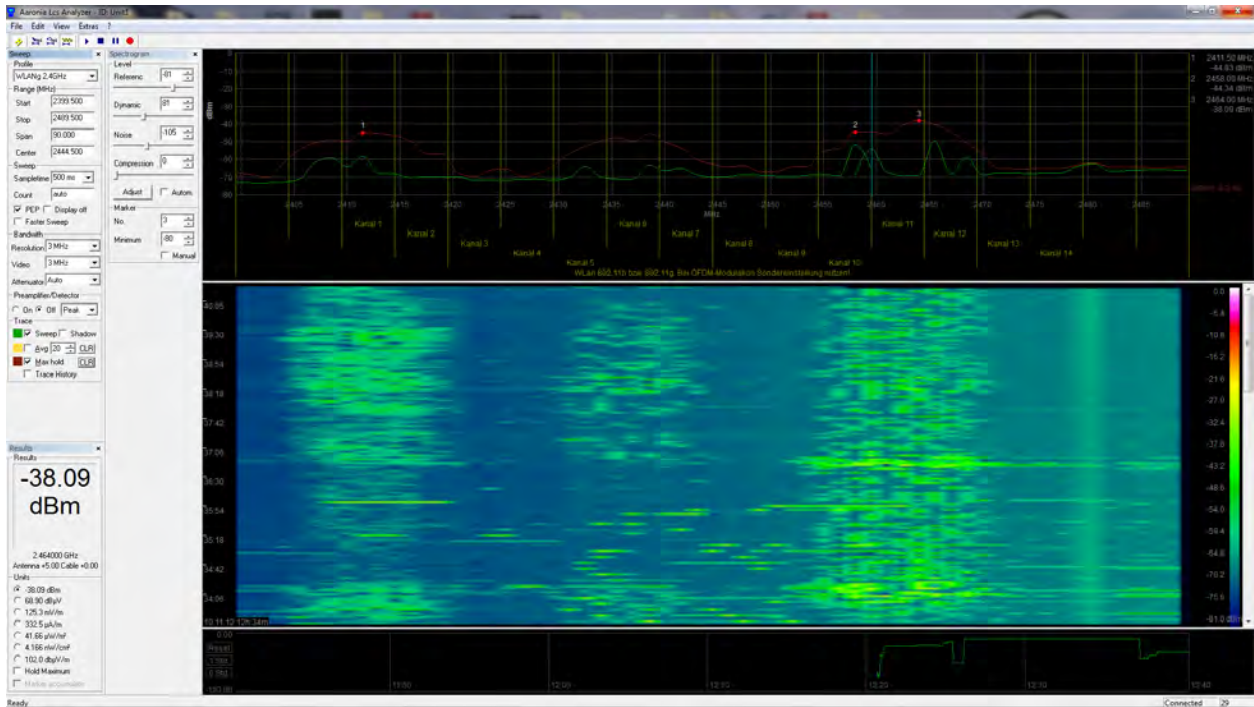
Figure 6 Peak signals under AP6 (disabled) 10:41 AM

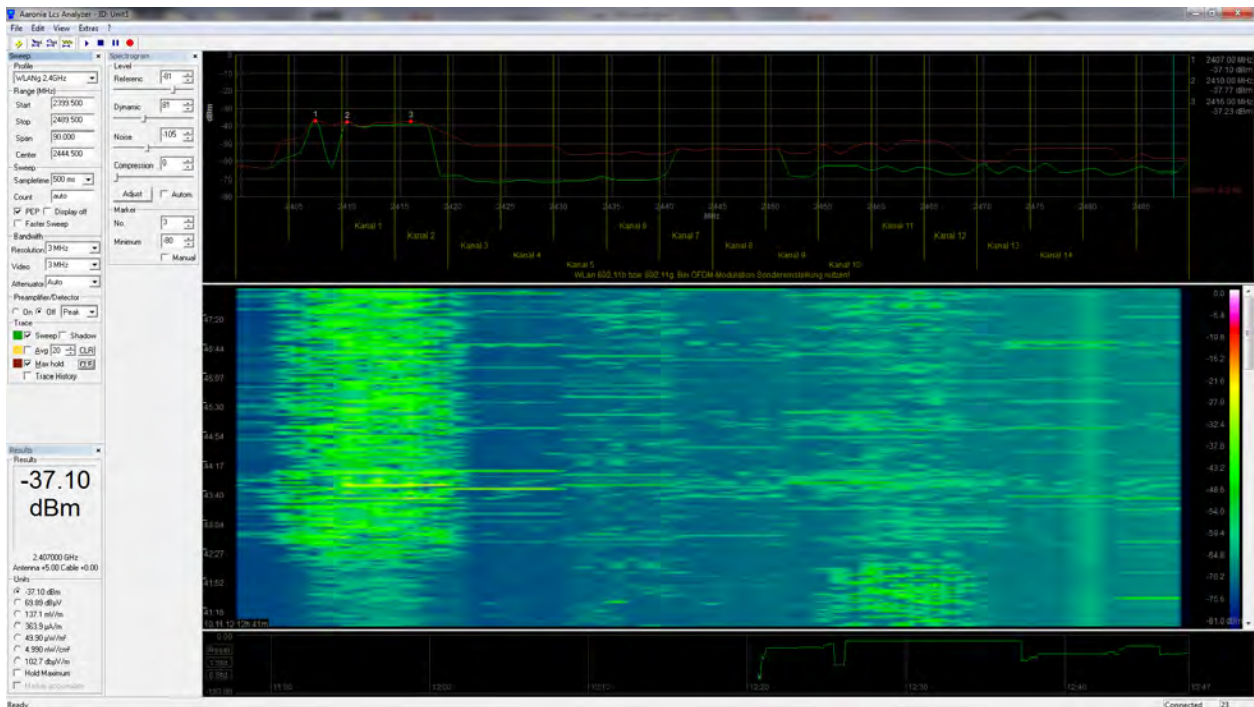
Figure 7 Peak Signals Near AP2 (not practical to block aisle beneath)

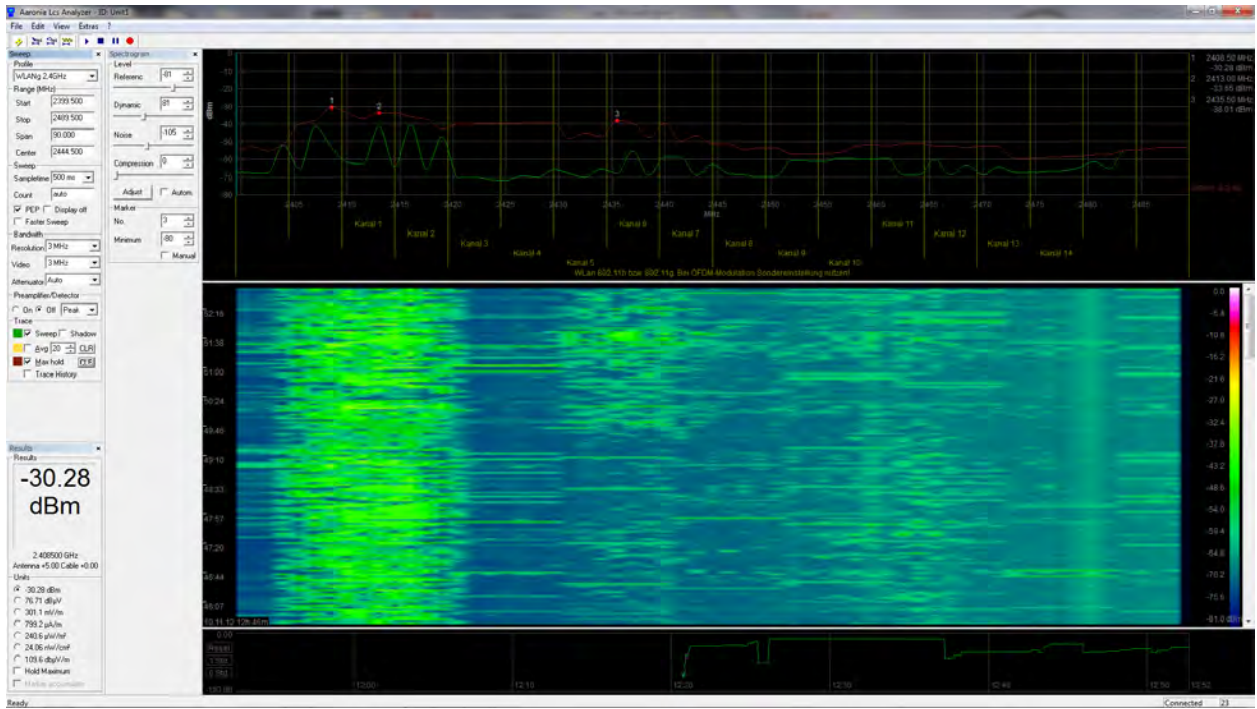
Figure 8 Peak Signals Beneath AP3

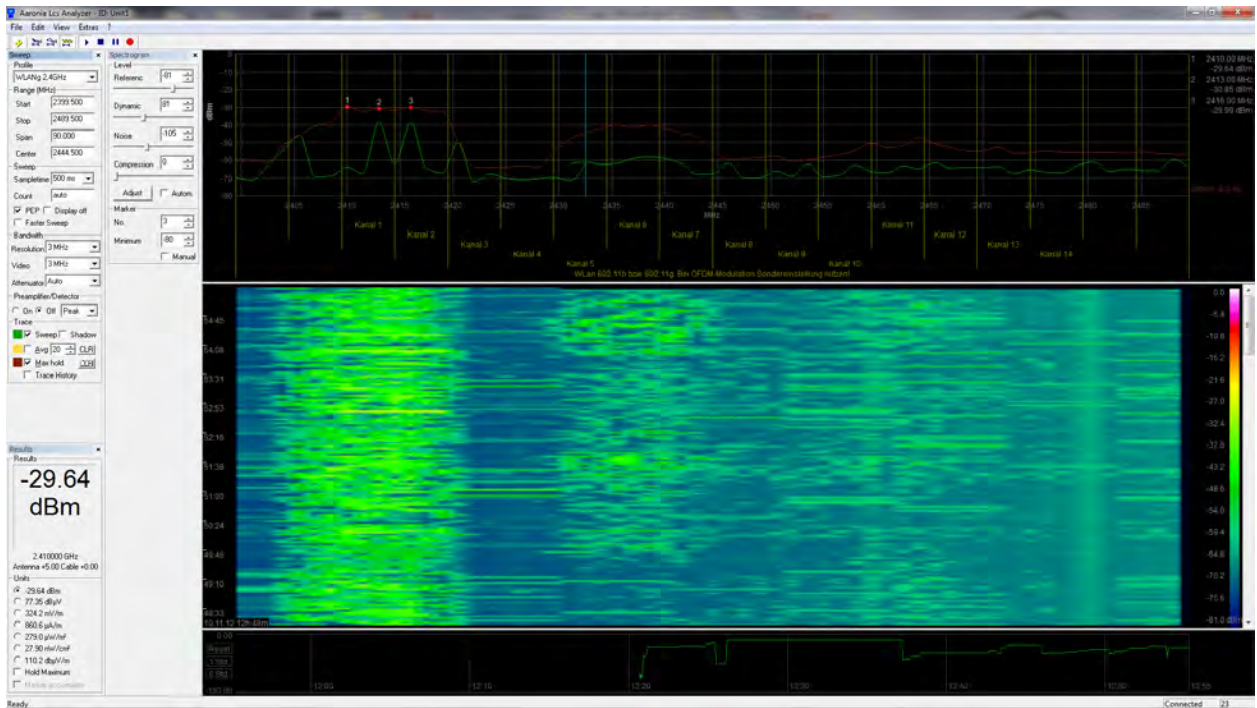
Figure 9 Peak energy Beneath AP3 facing AP4

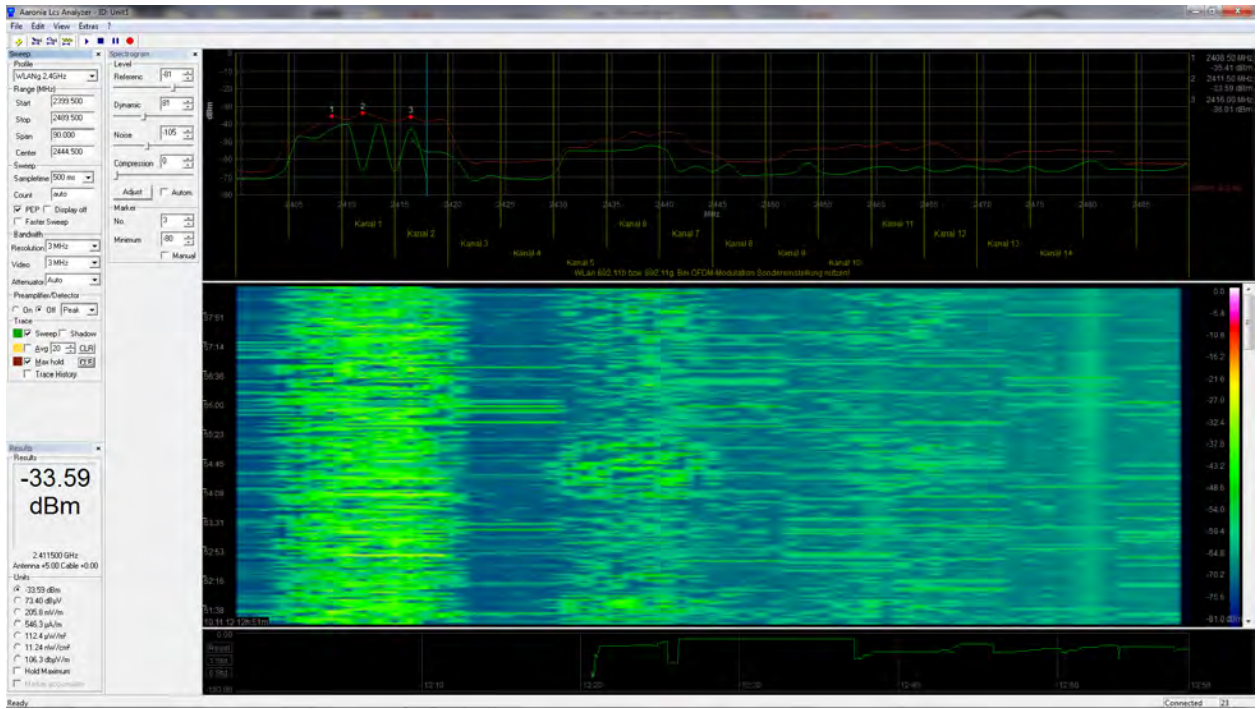
Figure 10 Peak signals Under AP3 facing AP1

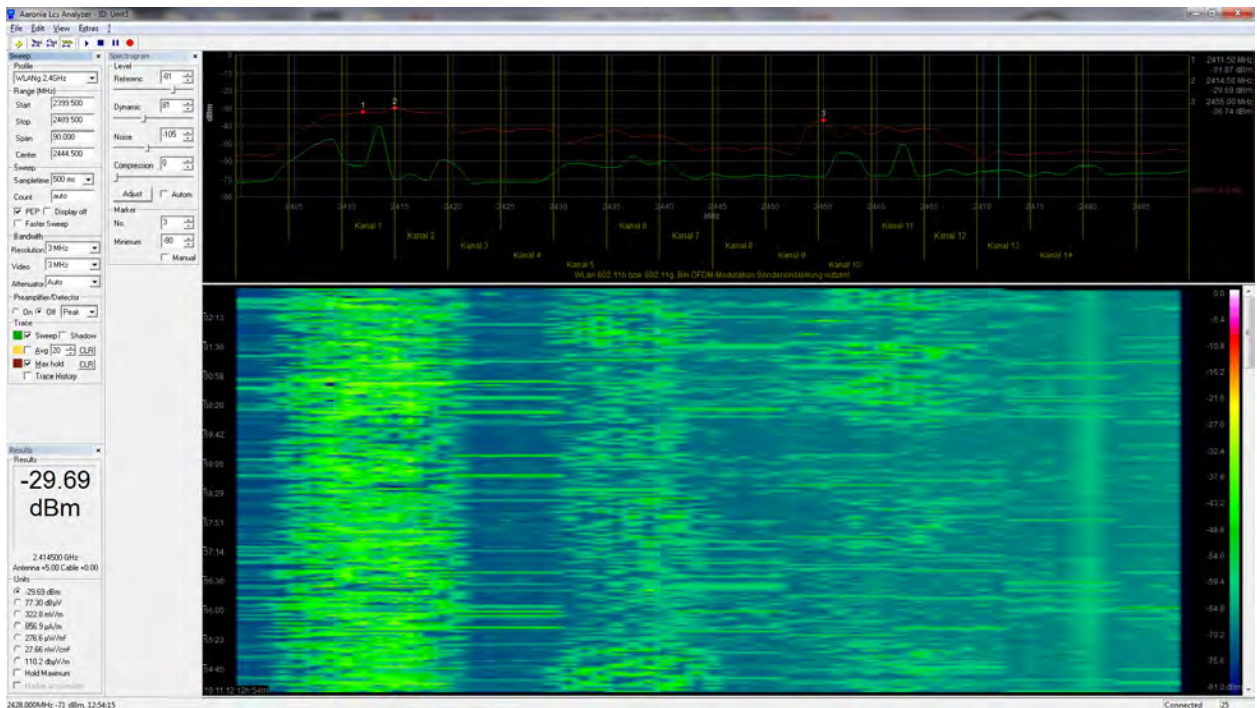
Figure 11 Peak Signals under AP1

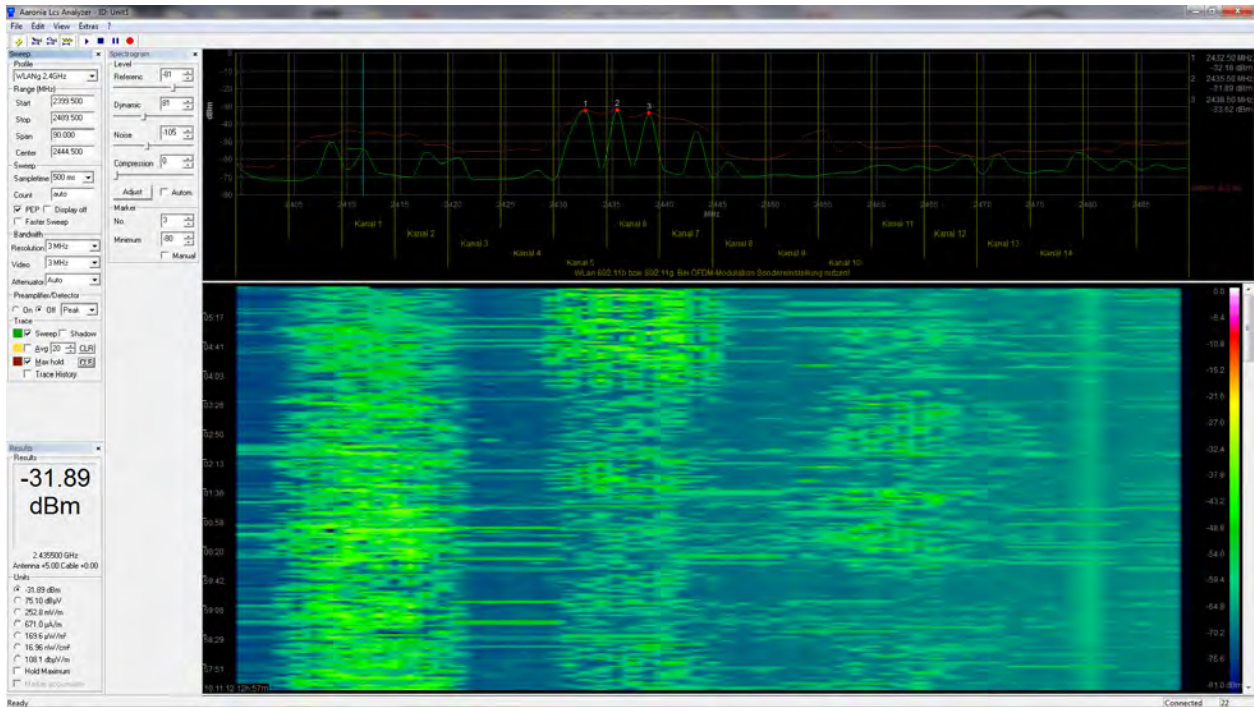
Figure 12 Peak signals under AP4

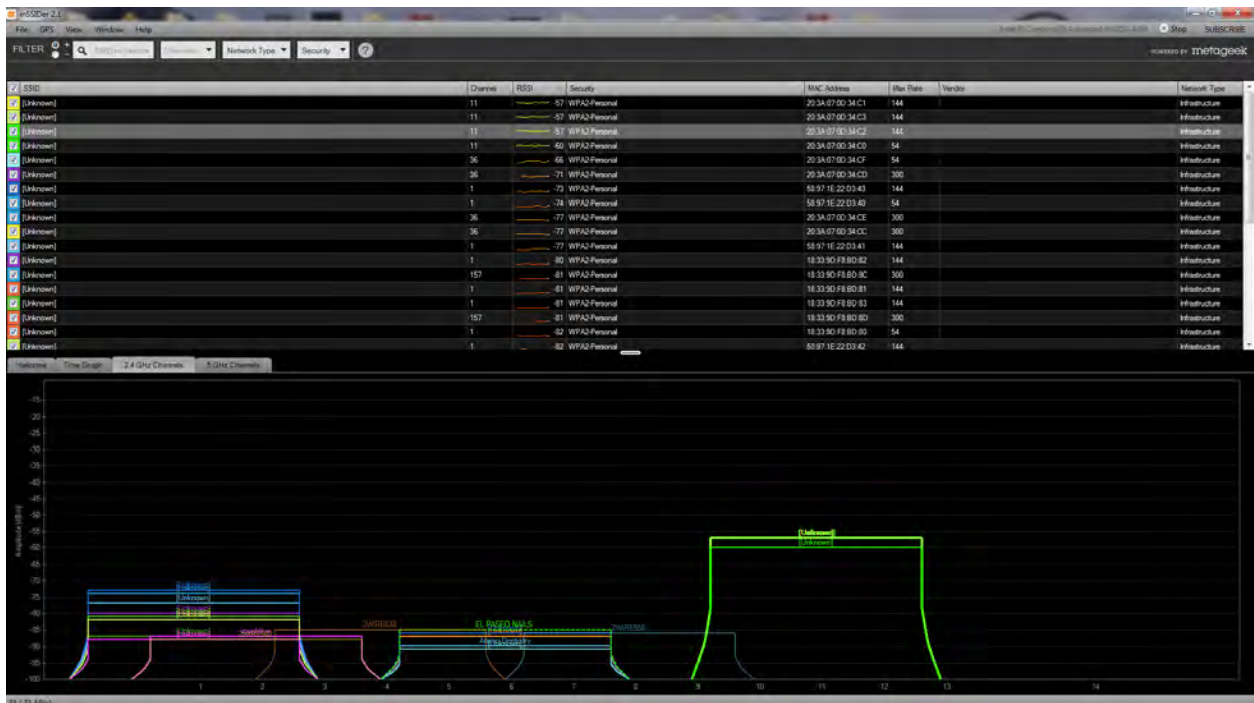
Figure 13 2.4 GHz nets from office

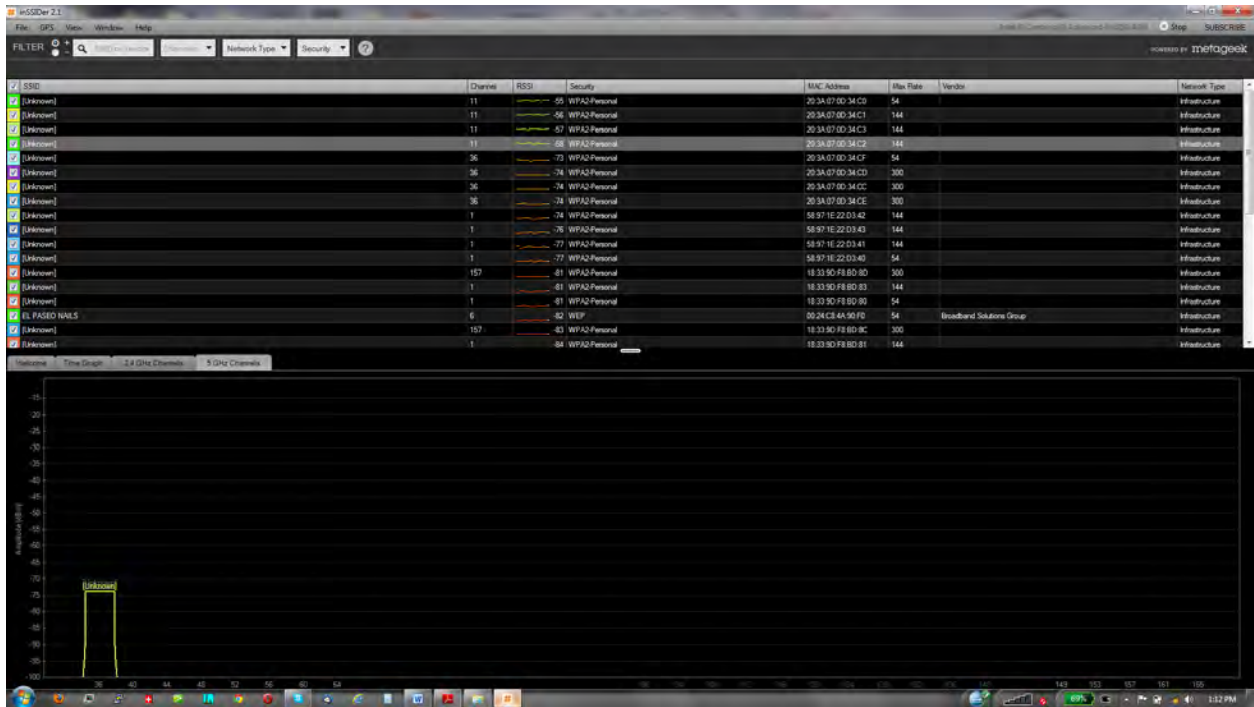
Figure 14 5 GHz LANs from Office

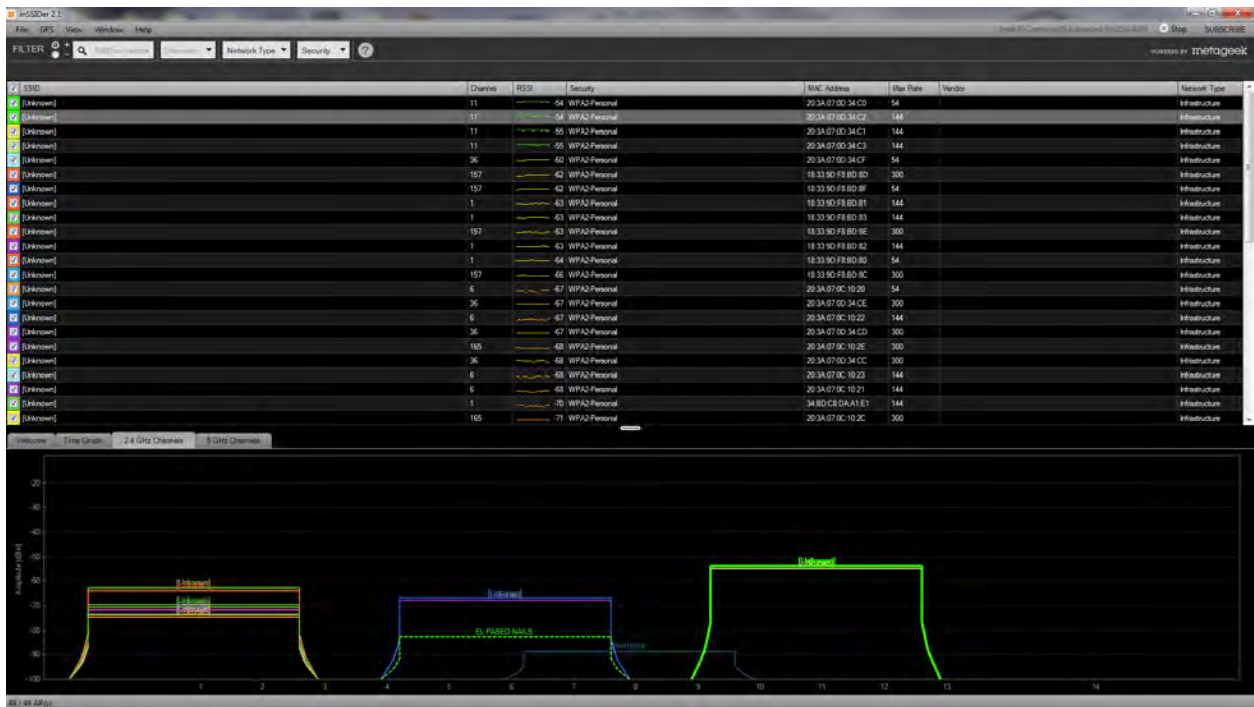
Figure 15 2.4 GHz LANs under AP6 (inactive)

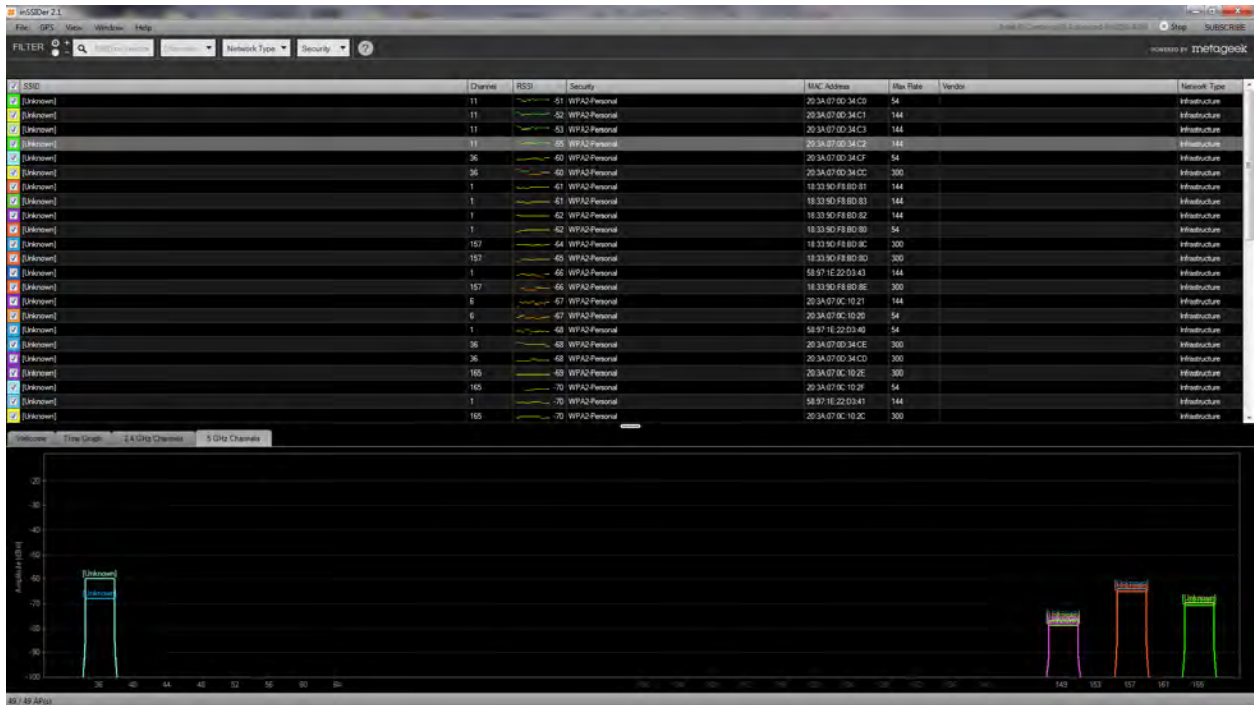
Figure 16 5 GHz LANs under AP6 (inactive)

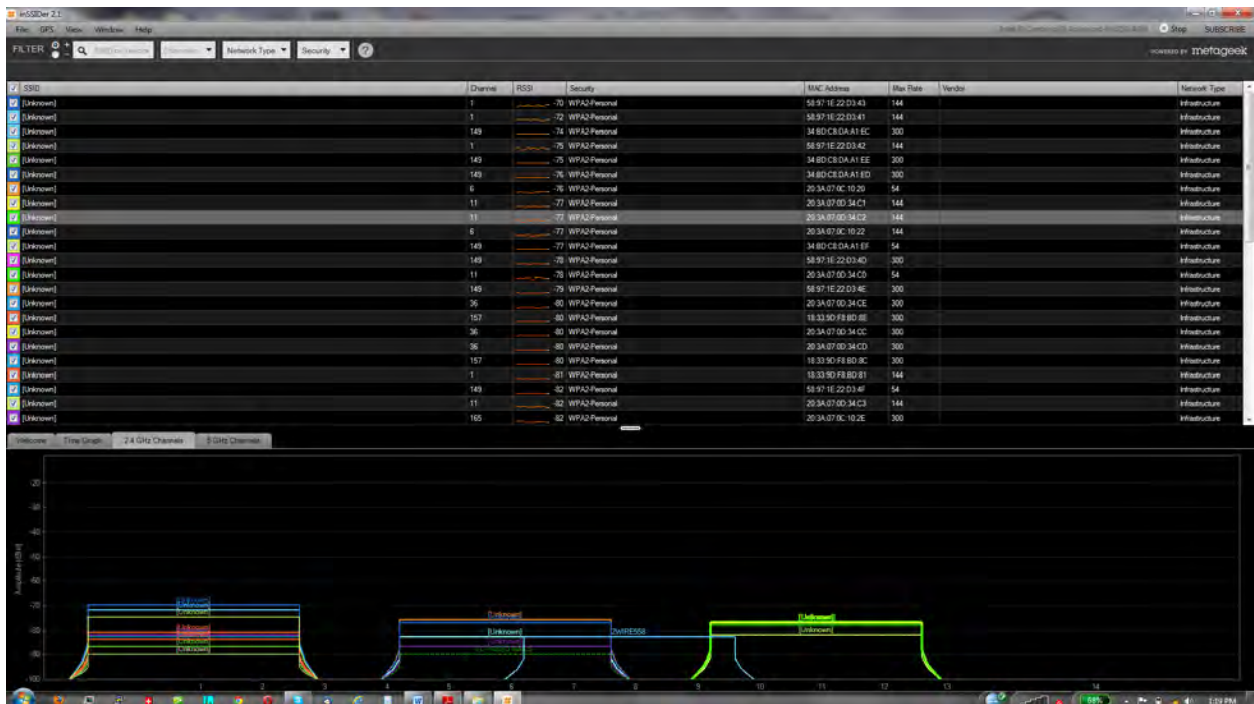
Figure 17 2.4 GHz LANs Far Rear Corner of store closest to AP6

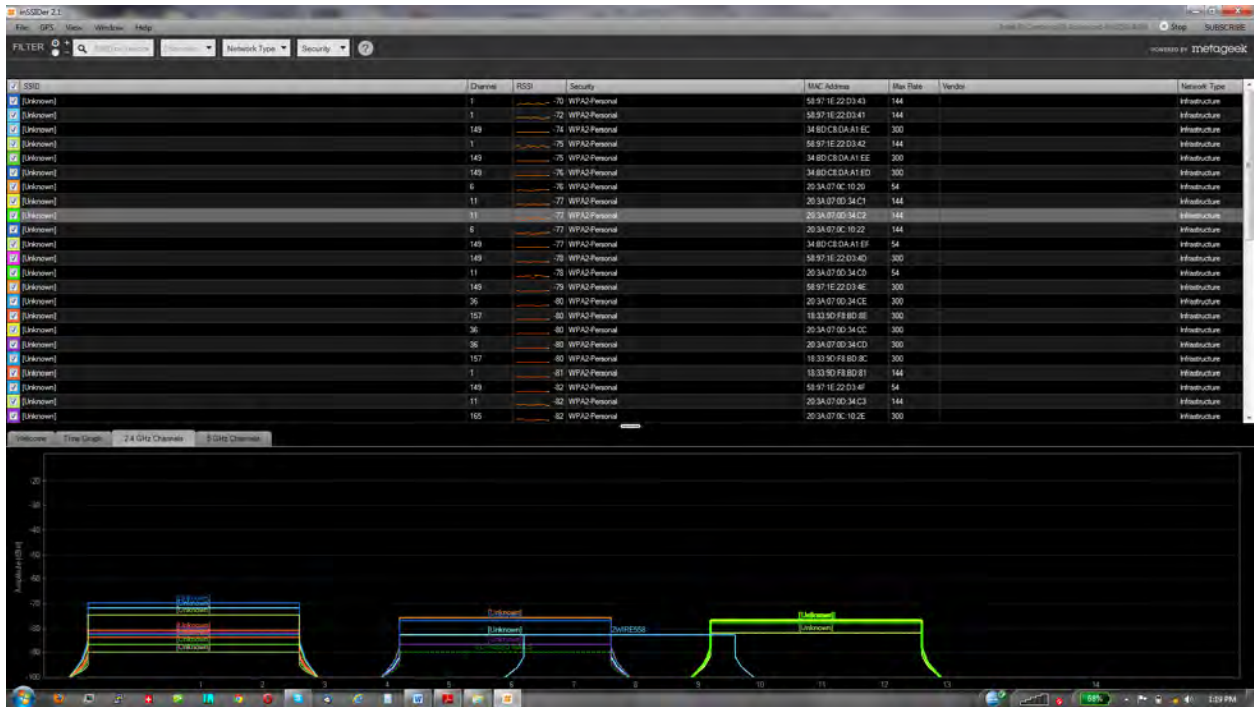
Figure 18 5 GHz LANs in Far Rear Corner of store closest to AP6

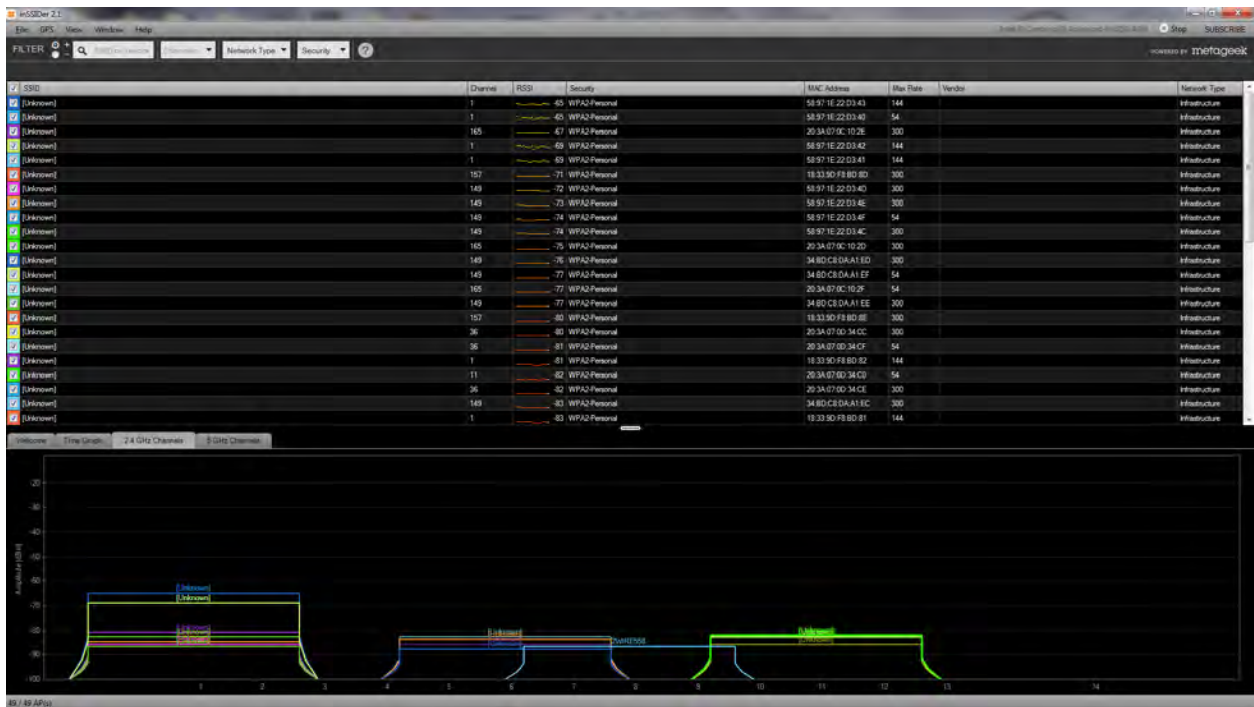
Figure 19 2.4 GHz LANs in Far Rear Corner of Store closest to AP2

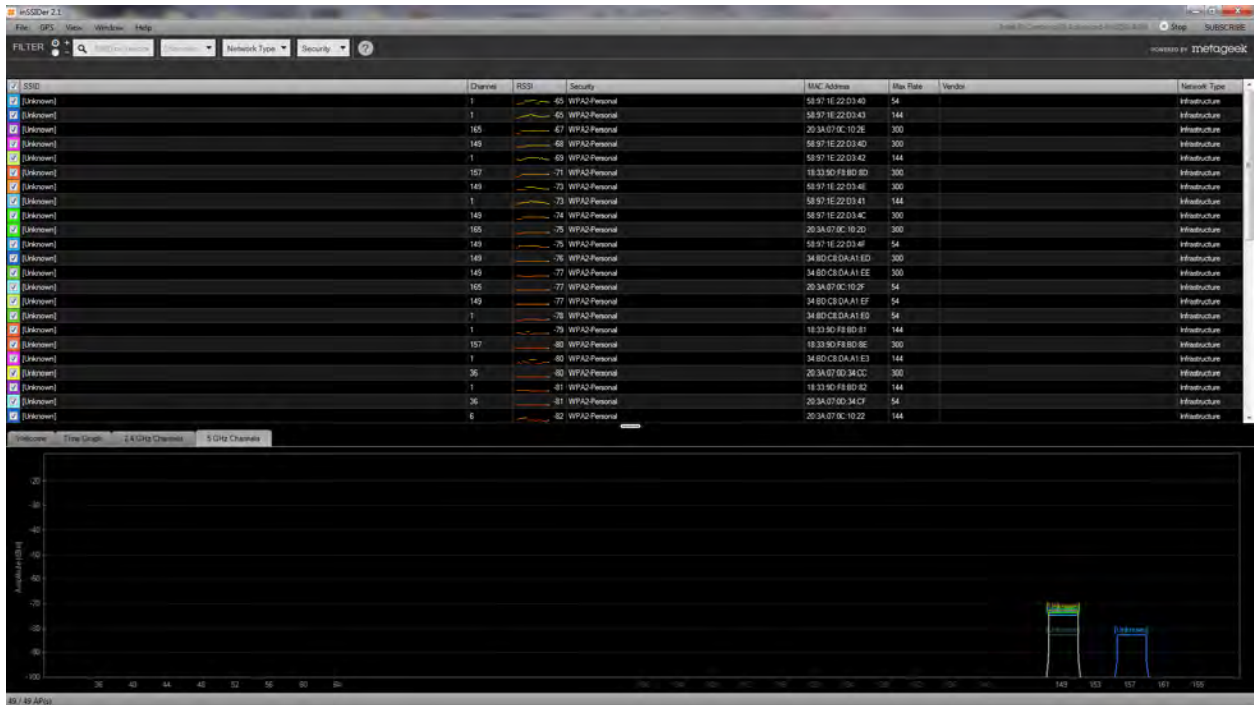
Figure 20 5 GHz LANs in Far Rear Corner of store closest to AP2

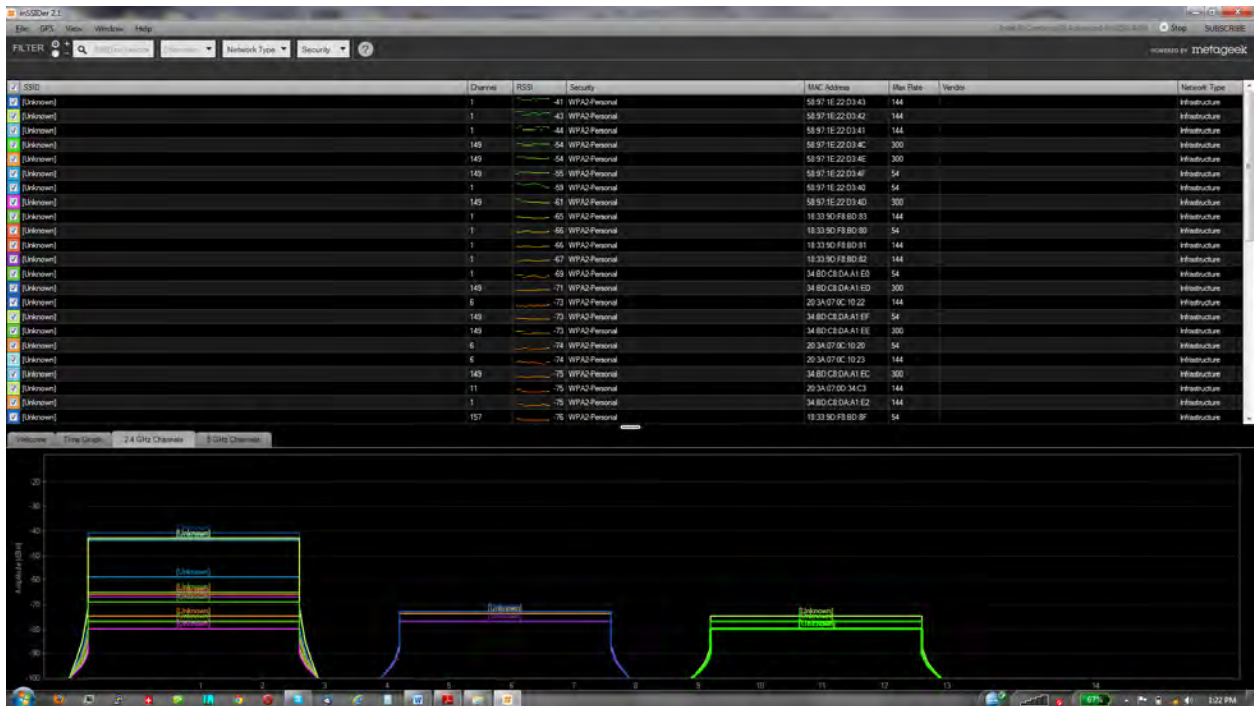
Figure 21 2.4 GHz LANs under AP2

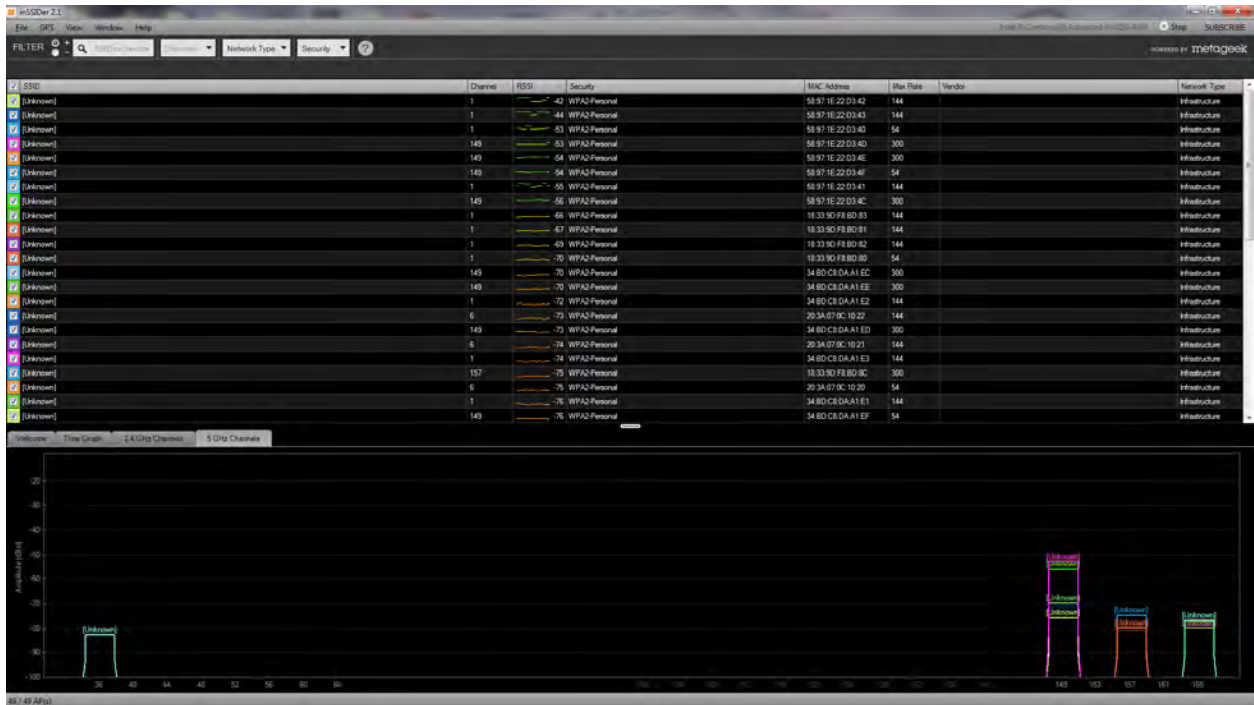
Figure 22 5 GHz LANs under AP2

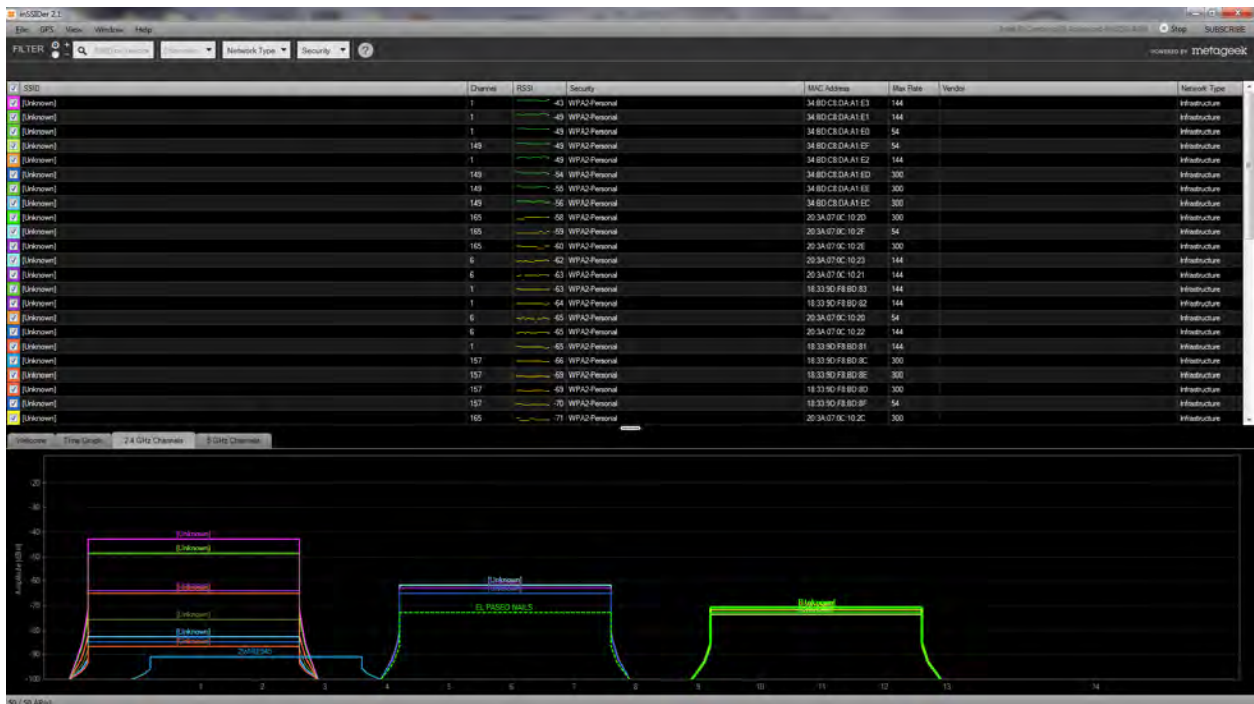
Figure 23 2.4 GHz LANs under AP3

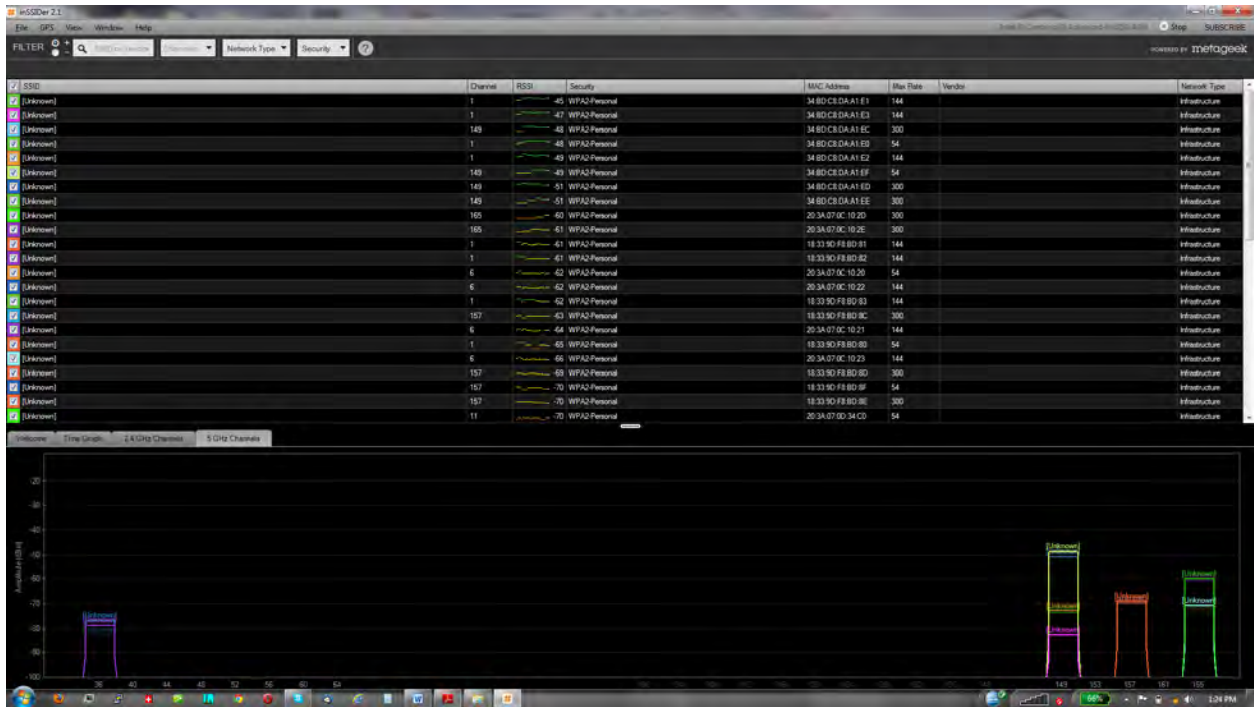
Figure 24 5 GHz LANs under AP3

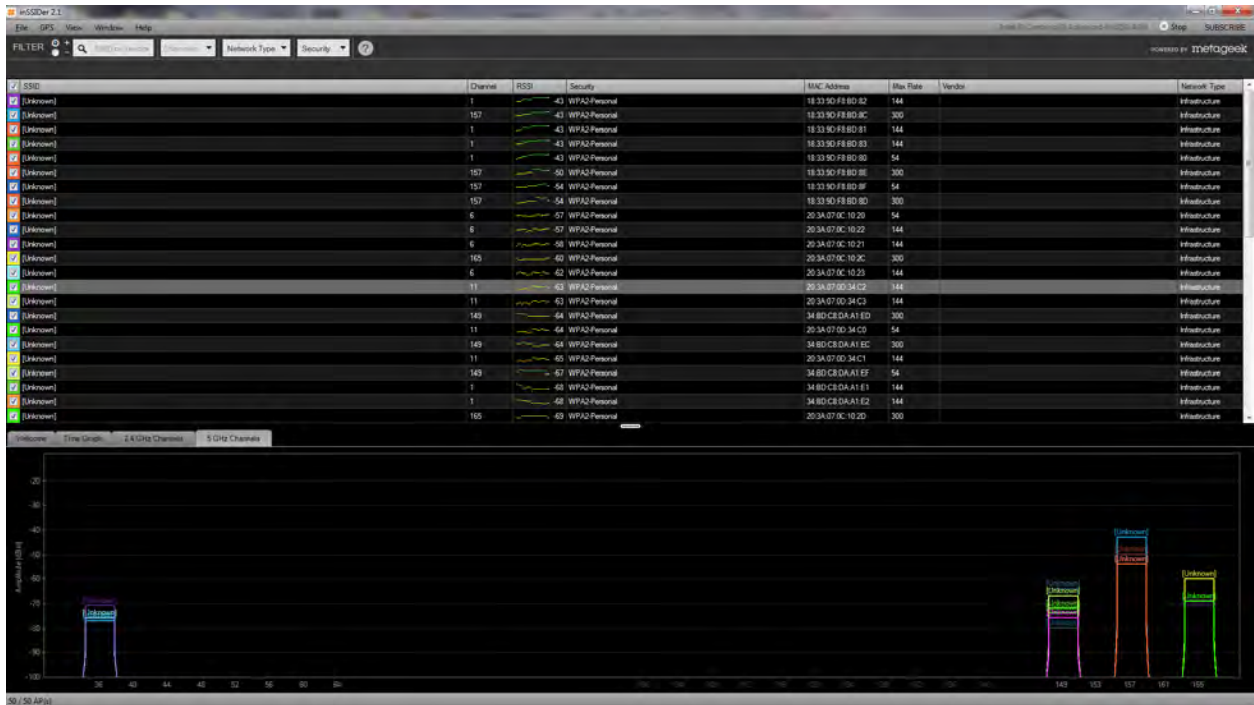
Figure 26 5 GHz LANs under AP1

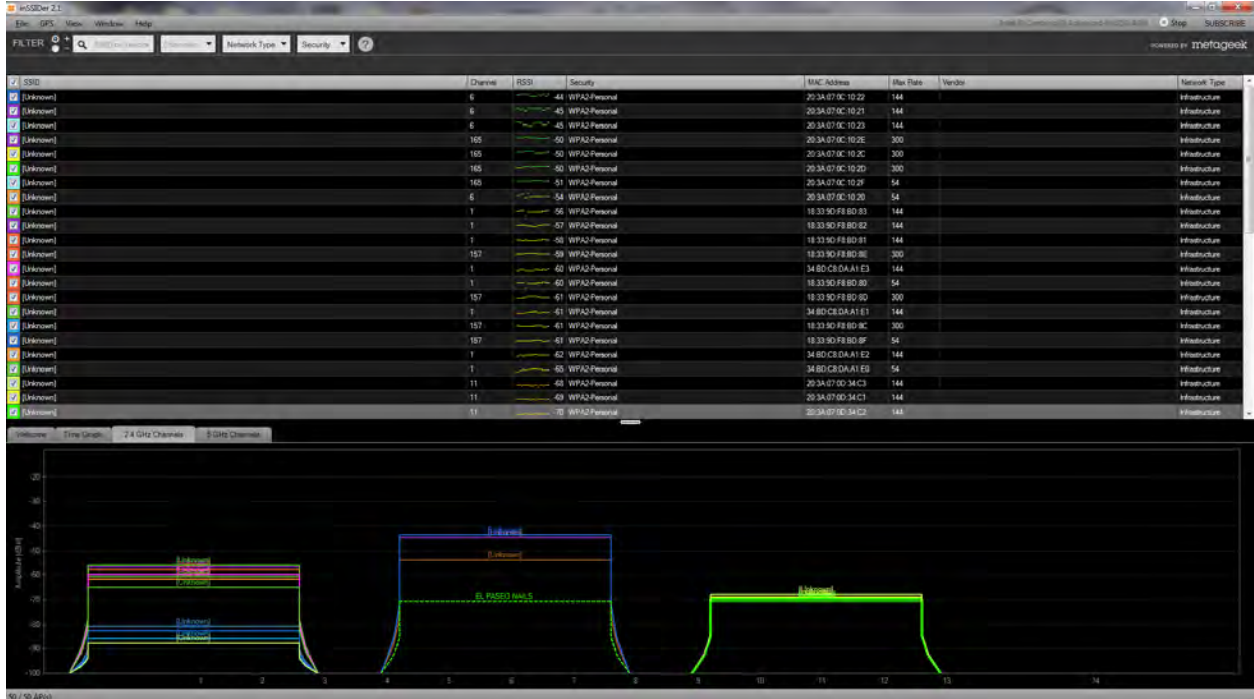
Figure 27 2.4 GHz LANs under AP4

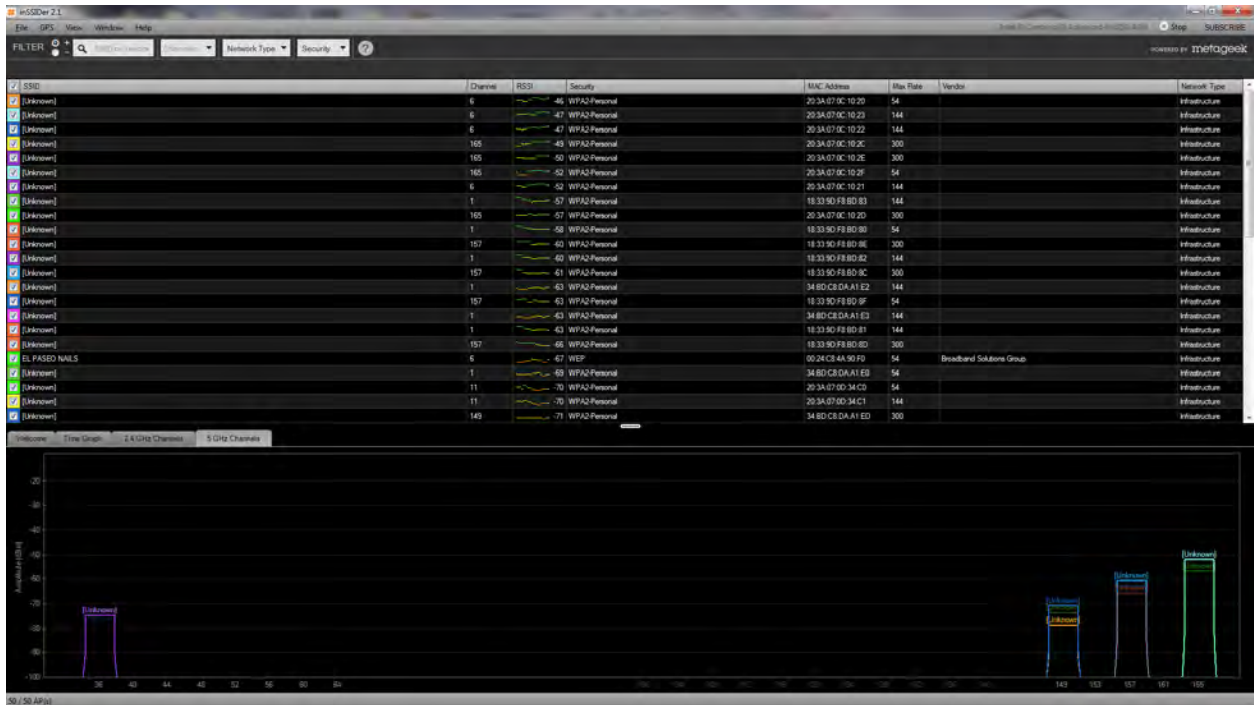
Figure 28 5 GHz LANs under AP4

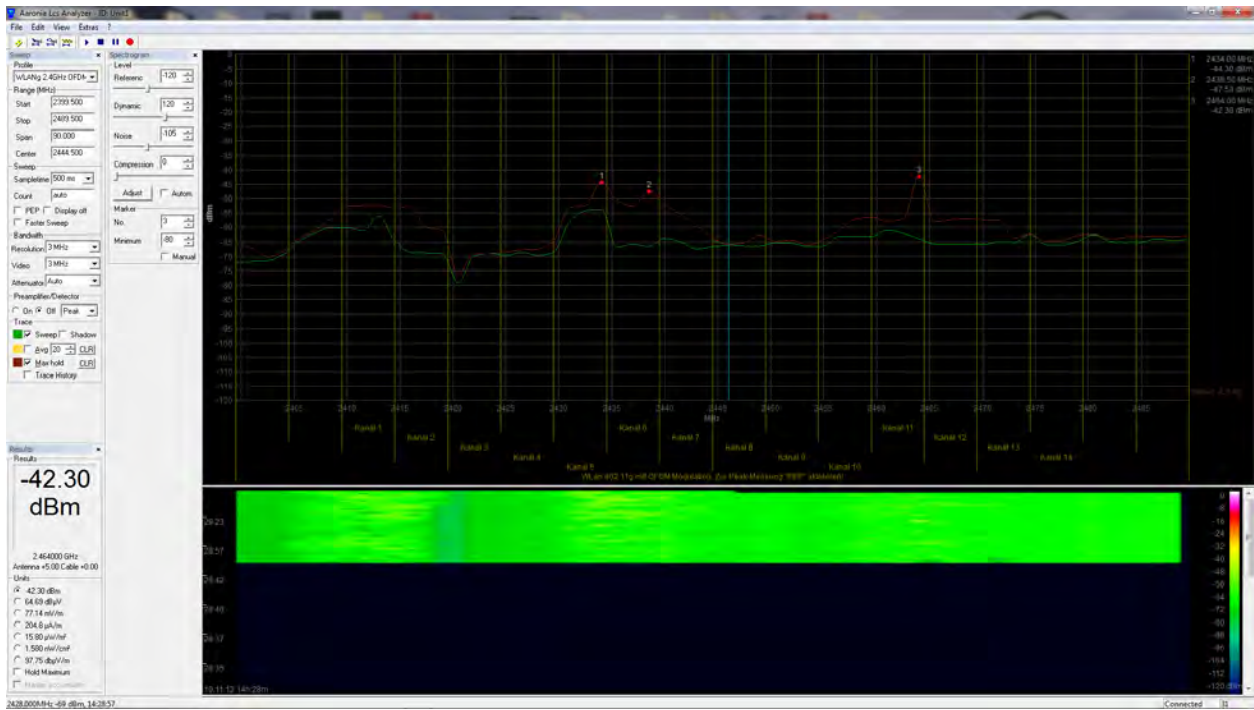
Figure 29 Peak Signals in 2.4 GHz Band at Far Rear Corner of store closest to AP6
