Introduction:

Reported Condition: Poor 2.4 GHz ISM connectivity in store corner, etc. Store served by 5 dispersed Cisco APs.

Site Survey: Storewide WiFi RF Environment

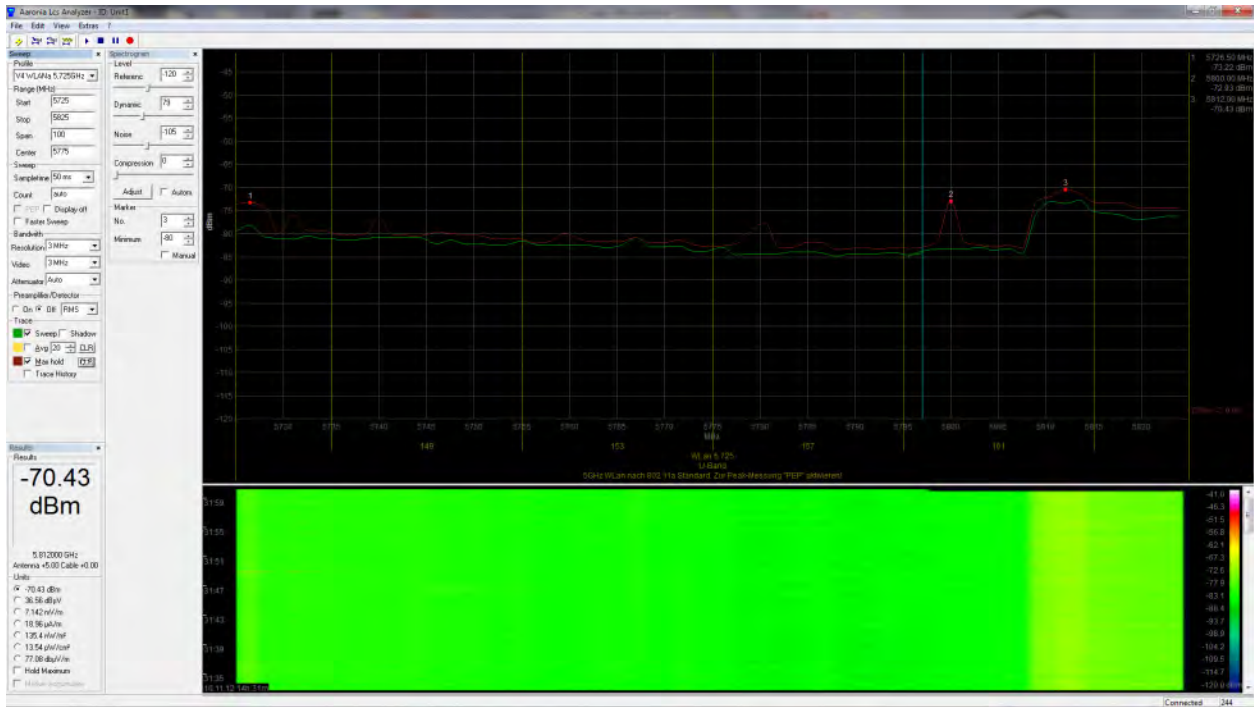
Figure 30 Peak Signals in 5 GHz band at Far Rear Corner of store closest to AP6
