Analysis of Radio Interference to Client System at... Omitted

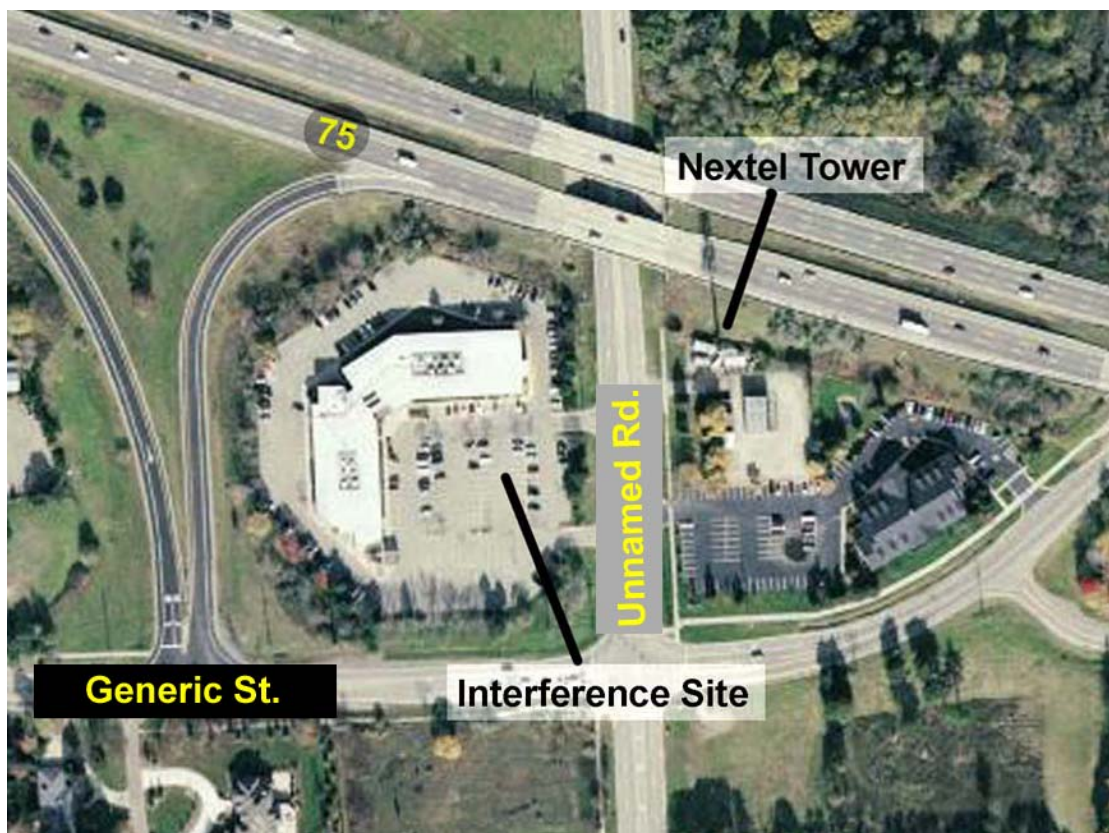
Figure 2, Generic St. at Unnamed Rd. Interference Location, Areal View

Next, Client’s representative and 360°RF’s engineer travelled to the interference location at the intersection of Generic St. and Unnamed Rd. to observe actual interference with several handheld radios. This site, pictured in **Figure 2**, is across the street from a large Nextel and Verizon site. **Figure 1** shows an aerial view of the site with the cellular tower and reception issue areas marked.
