Introduction:

360°RF was retained to independently test four point-to-point 4.9 GHz public safety radio systems manufactured by a leading brand for performance versus published specifications. Further, 360°RF analyzed and/ or tested these devices' construction, circuitry, harmonics and microphonics, leads, materials, and solder joints.

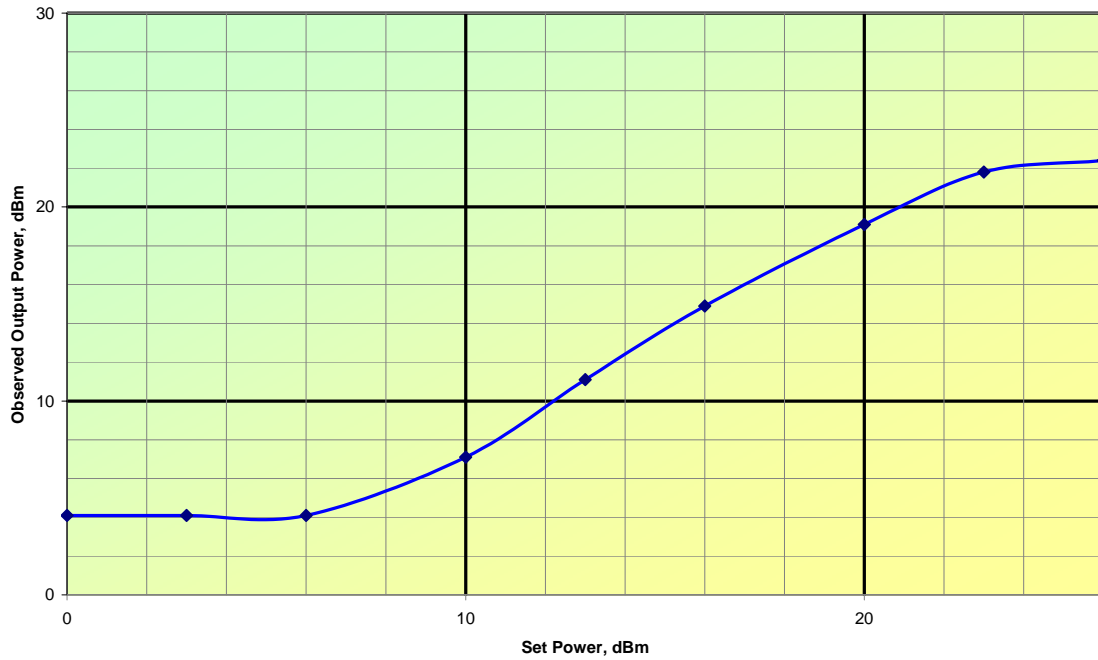
Observed RF Power vs. Set Power

Observed power adjustments were reasonably linear if not accurate in the range of +6 to +23 dBm. The graph below is for ODU serial number ODU-4. All units were observed to have similar performance.

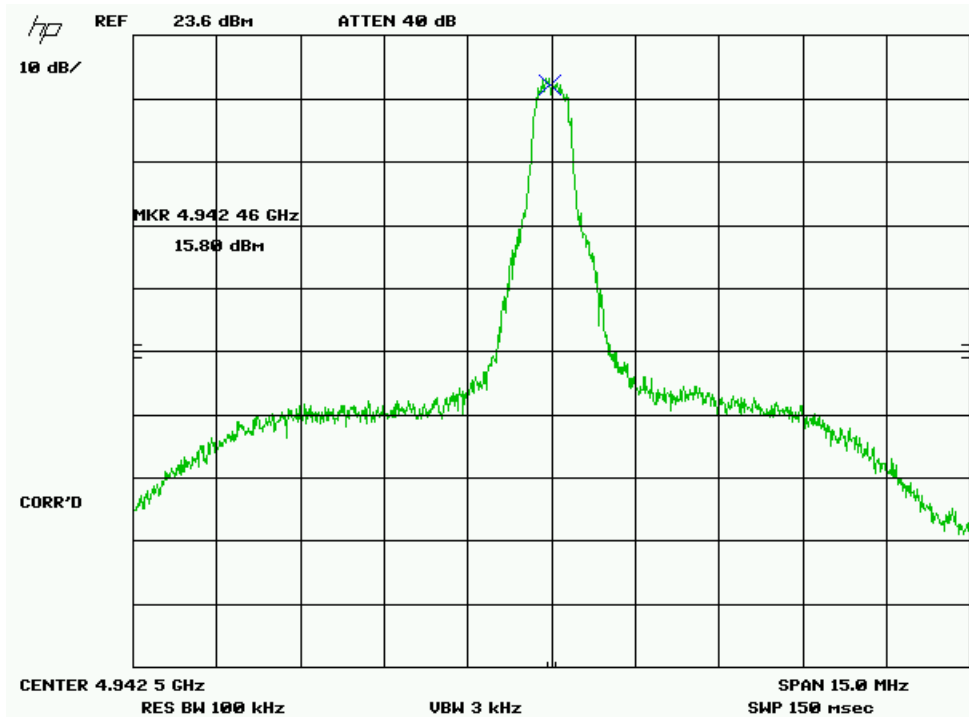
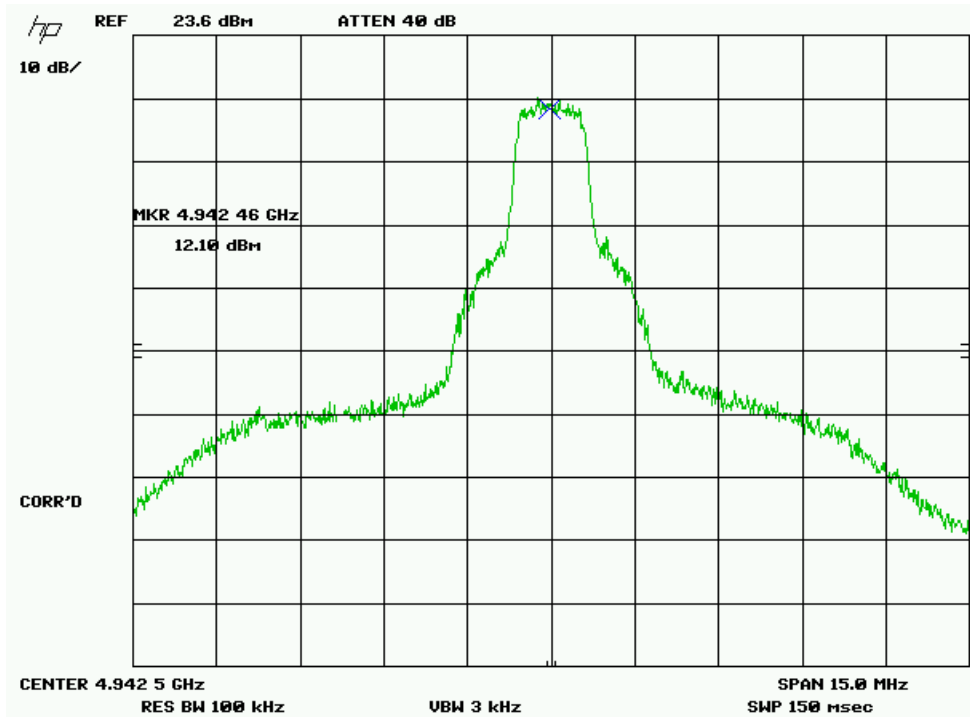
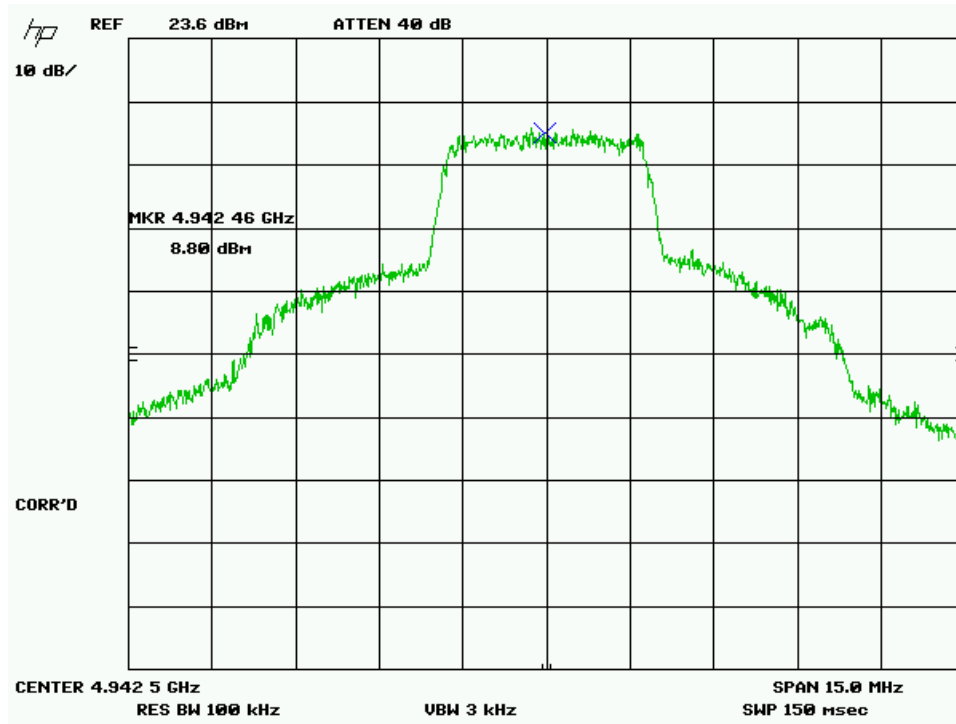
The following are spectrum displays of radio ODU-4 at 1 MHz, 2 MHz and 5 MHz bandwidth respectively. Bandwidth was adjusted using the on-board configuration software in the ODU through the Ethernet port.

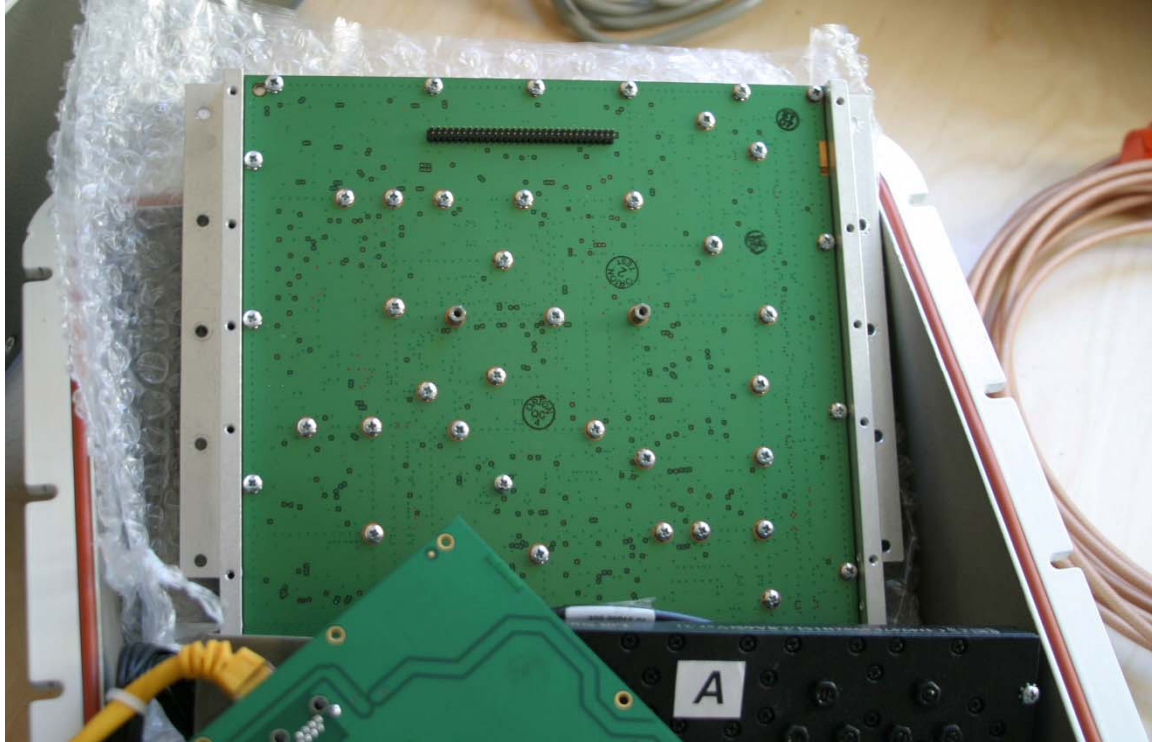
Next, the duplexer and control PCB were removed from the aluminum housing to expose the RF board. The RF board is inverted into the machined aluminum housing and held in place by 55 screws and four stand-offs (see below).

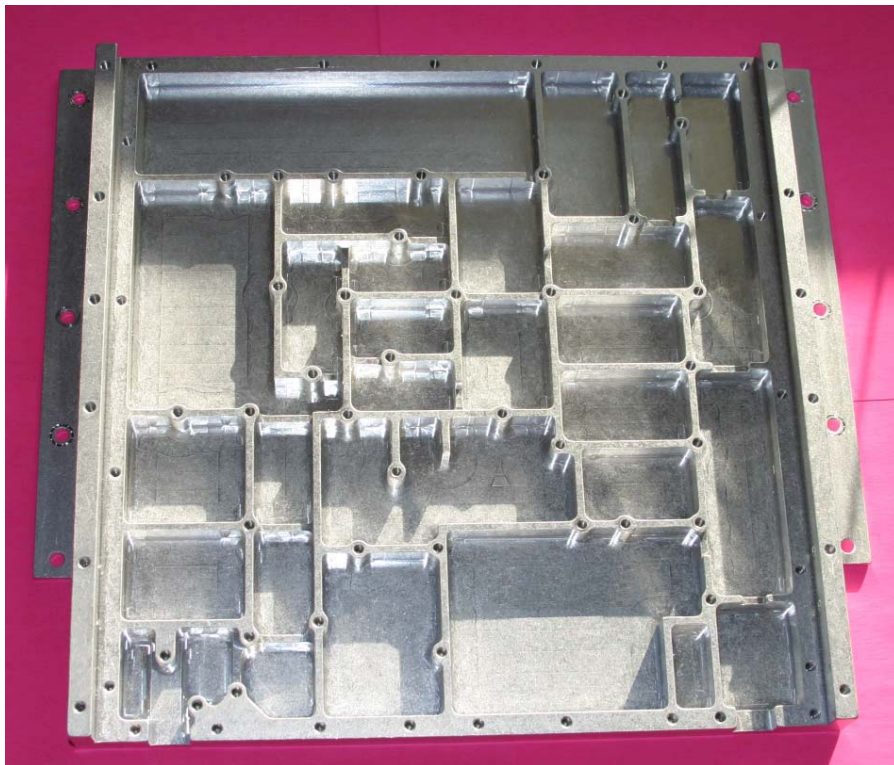
All of these screws were removed and the RF board as examined in further detail (see photos below).

All four units appear to be well constructed with proper attention given to separation of RF and digital functions, grounding and sturdiness. The units matched the specifications provided. All four units did, however, exhibit what we would consider moderate microphonic susceptibility. It is our opinion that these units would probably not suffer from localized rain as an microphonic source. Other mechanical vibrations such as the shimmy of a pole in the wind or any metal-on-metal vibrations would likely induce noise sufficient to generate error conditions, however. A comprehensive analysis of path attenuation versus error rate, and/or to determine the threshold for errors due to different stimuli, can be conducted at additional cost.

The microphonic condition could be caused by any of a number of design issues. Common problems include local oscillators, themselves, SAW filters and resonant cavity effects. Soldering problems are also a possible contributing source; but it is less likely that all four units have the same manufacturing flaw, and much more likely that they share a common design flaw.
