Introduction:

Reported Condition: Poor 2.4 GHz ISM connectivity in store corner, etc. Store served by 5 dispersed Cisco APs.

Site Survey: Storewide WiFi RF Environment

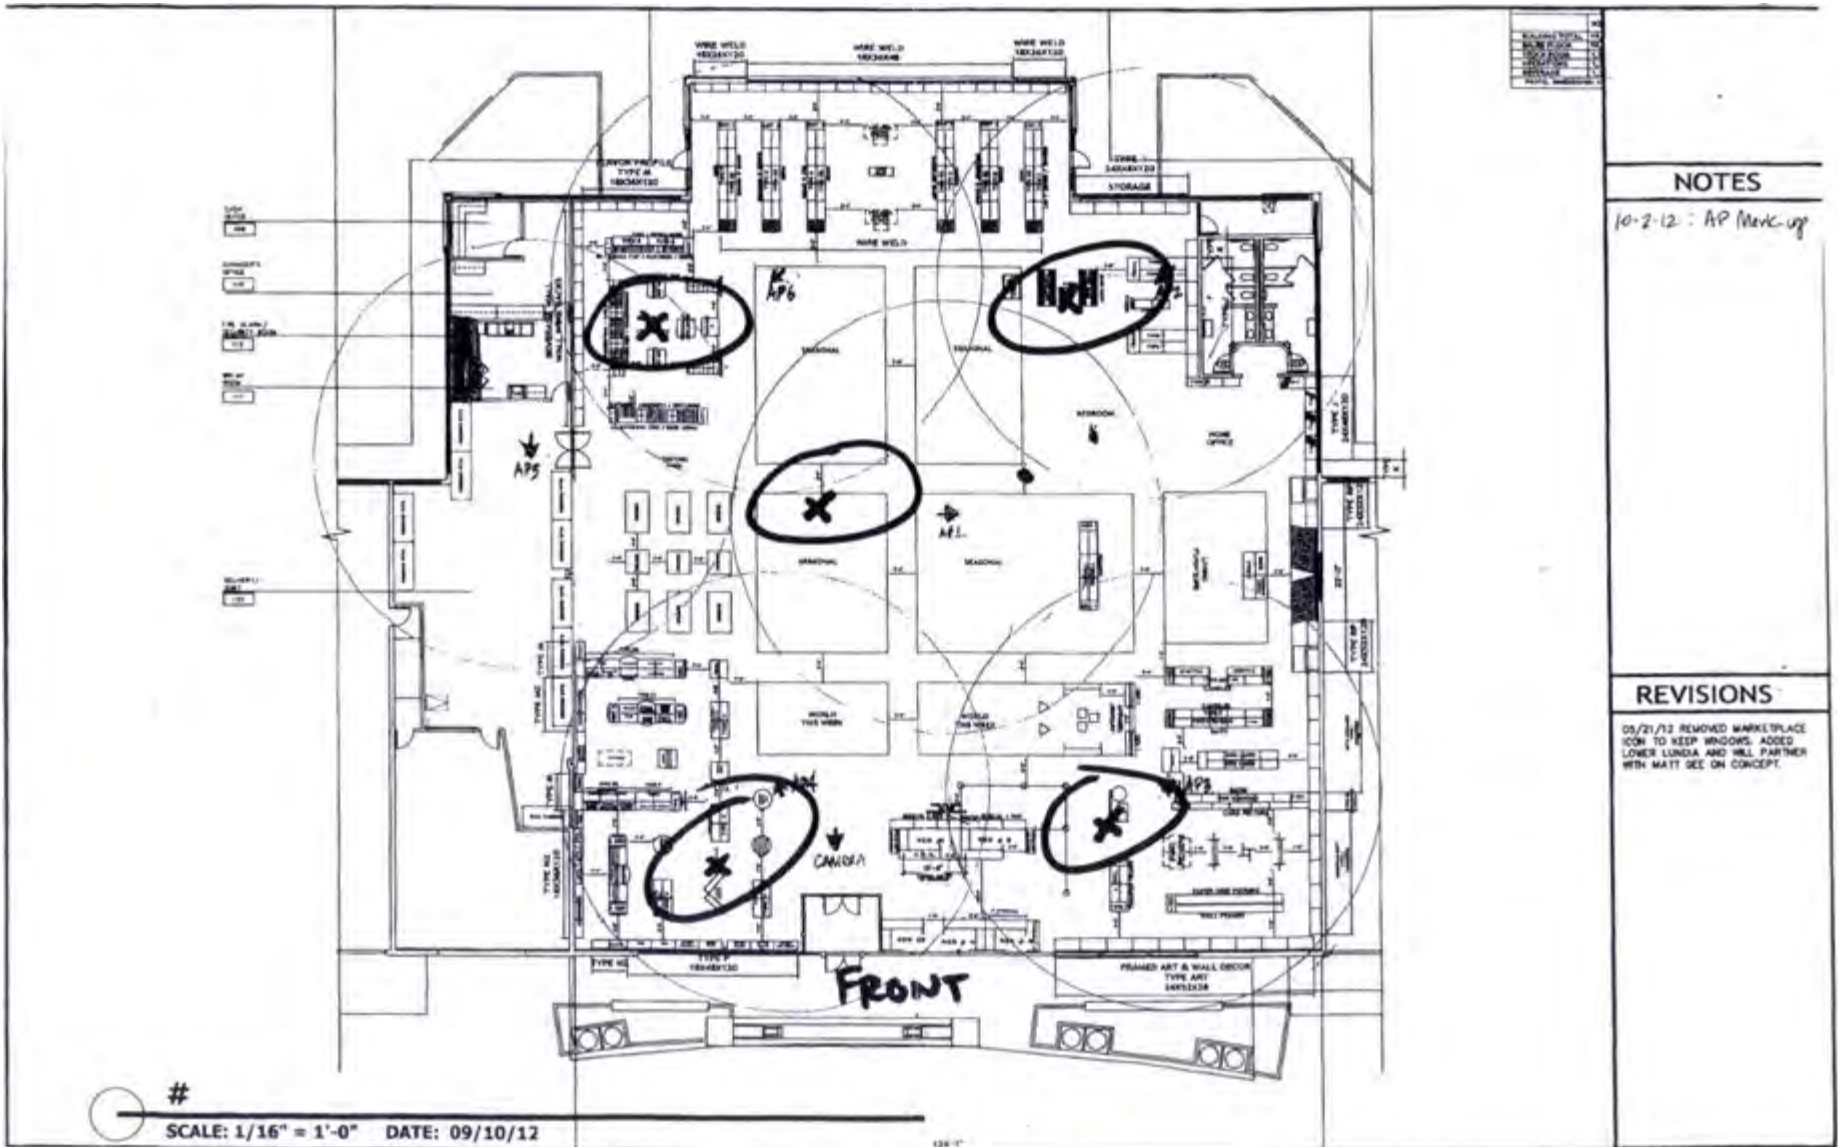
Figure 4 ... Store #555 Layout

AP5 should have been located in the warehouse according to Figure 3 shown on page 4. The actual location of the AP is above the entry to the break room. See Figure 2, below. This may have been caused by the fact that the warehouse entry doors are not located as shown on the drawing in Figure 3, and instead are set back from the location shown in the drawing. Ideally this AP should be located in the center of the warehouse or slightly toward the front of the store.
